Silly Sockets!

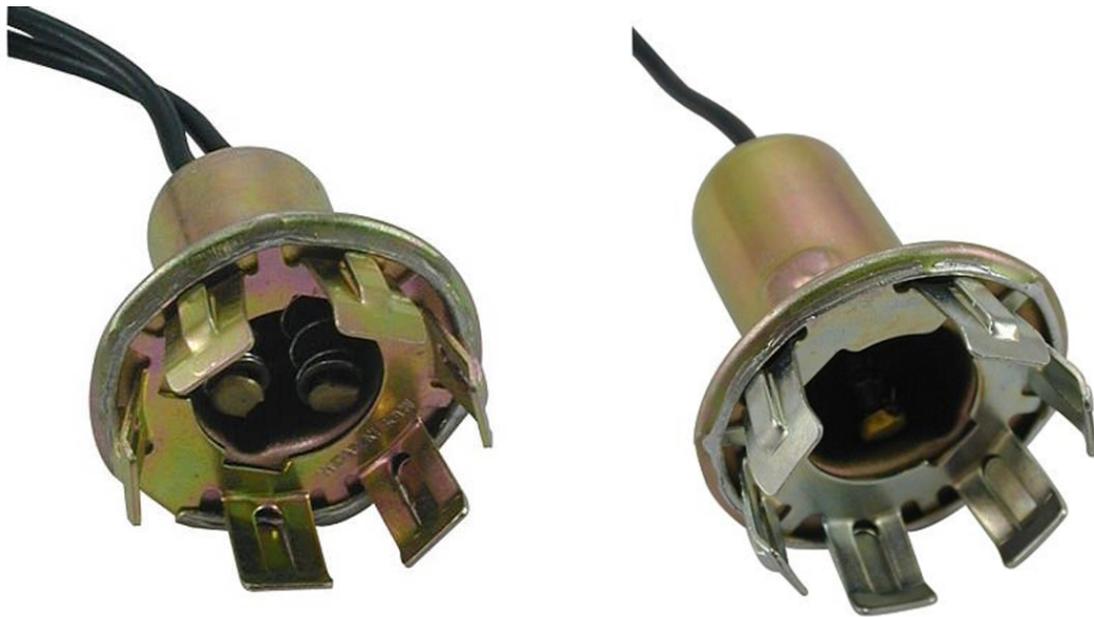
Here are photos of the 2-wire and 1-wire JT&T sockets.
