# CHEVROLET

# SERVICE NEWS

MARCH, 1961

## HYDRAULIC LIFTERS USED IN V-8 AND CORVAIR ENGINES

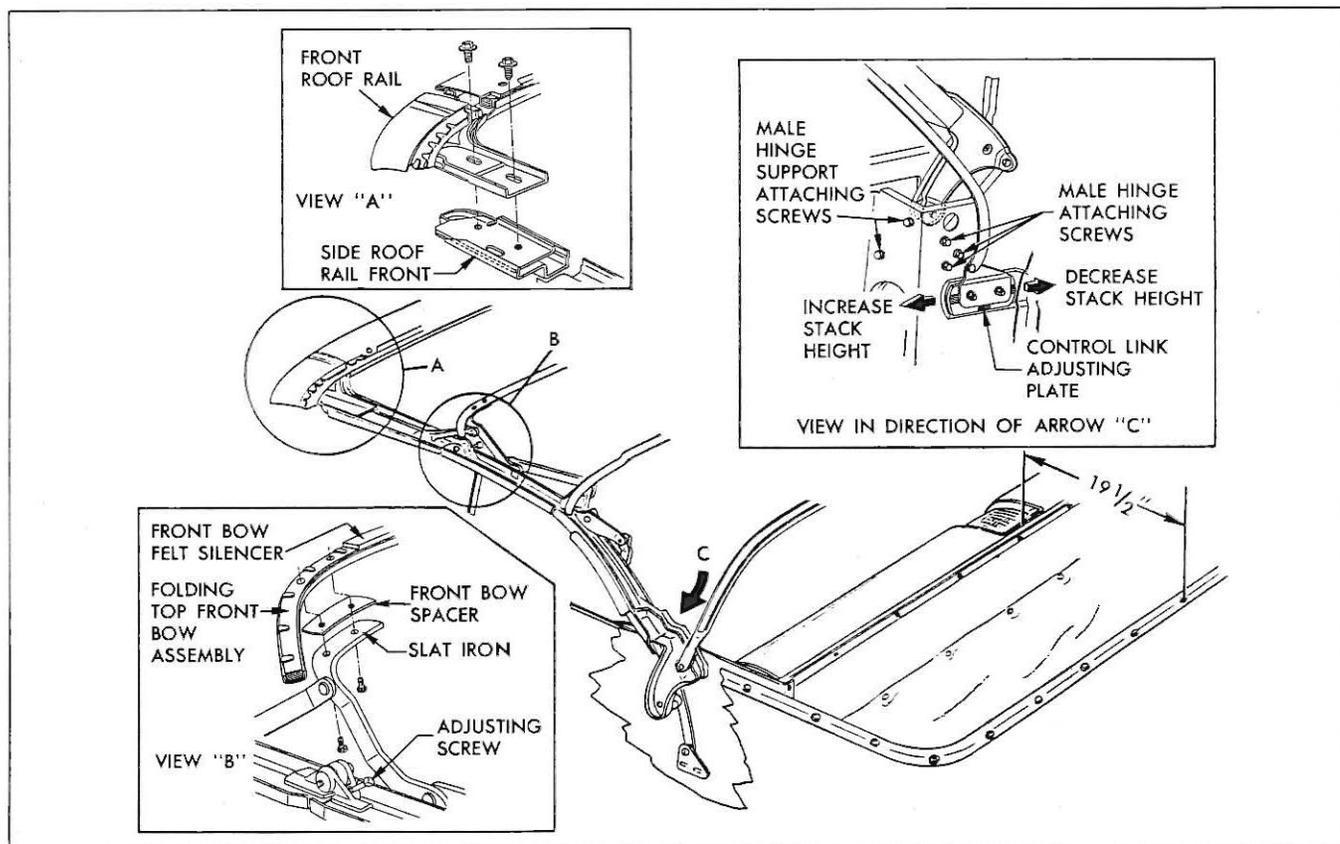
Fig. 2—Folding Top Alignment Areas

CONDITION	APPARENT CAUSE	CORRECTION
<b>Difficult locking action at front roof rail.</b>	Sunshade support misaligned. Lock hook lever improperly adjusted. Misaligned front roof rail front weatherstrip. Front roof rail misaligned.	Adjust sunshade support laterally. Adjust lock hook lever counterclockwise. Loosen, realign and retack front roof rail front weatherstrip. Adjust front roof rail.
<b>Top does not lock tight enough to windshield header.</b>	Sunshade support misaligned. Lock hook lever improperly adjusted. Misaligned front roof rail front weatherstrip. Front roof rail misaligned.	Adjust sunshade support laterally. Adjust lock hook lever clockwise. Loosen, realign and retack front roof rail front weatherstrip. Adjust front roof rail.
<b>Top travels too far forward.</b>	Front roof rail misaligned. Male hinge assembly misaligned.	Adjust front roof rail rearward (See Figure 1—View "A"). Adjust male hinge rearward (View "C").

<b>Top does not travel forward far enough.</b>	Front roof rail misaligned. Male hinge assembly misaligned.  Improper spacing between rear trim stick and body metal.	Adjust front roof rail forward (View "A"). Adjust male hinge assembly forward (View "C").  Install an additional spacer between rear trim stick and body metal at each attaching bolt location.
<b>Side roof rail rear weatherstrip too tight against rear of rear quarter window.</b>	Male hinge assembly misaligned.	Adjust male hinge assembly rearward (View "C").
<b>Gap between side roof rail rear weatherstrip and rear of rear quarter window.</b>	Male hinge assembly misaligned.	Adjust male hinge assembly forward (View "C") and/or shim side roof rail rear weatherstrip forward as required.
<b>Side roof rail rear weatherstrip too tight against top of rear quarter window.</b>	Male hinge support misaligned.	Adjust male hinge support upward (View "C").

<b>Gap between side roof rail rear weatherstrip and top of rear quarter window.</b>	Male hinge support misaligned.	Adjust male hinge support downward (View "C") and/or shim side roof rail rear weatherstrip downward.
<b>Sag at front to center side roof rail joint.</b>	Control link adjusting plate misaligned. Center side roof rail hinge adjusting screw improperly adjusted.	Adjust control link adjusting plate downward (View "C"). Adjust screw counterclockwise (View "B").
<b>Wind whistle or waterleak along front roof rail.</b>	Top does not lock tight enough to windshield header. Misaligned, front roof rail front weatherstrip. Front roof rail contour does not conform to windshield header.	Adjust sunshade support laterally and/or adjust lock hook lever clockwise. Retack front weatherstrip to front roof rail. Contour of front roof rail may be changed slightly by reforming rail.
<b>Folding top dust boot fits too loosely.</b>	Improper stack height due to misaligned control link adjusting plate. Rear seat back assembly is too far rearward.	Adjust control link plate forward (View "C"). Relocate rear seat back panel forward until distance between upper rear edge of rear seat back to forward edge of pinchweld finishing molding is $19\frac{1}{2}$ inches $\pm \frac{1}{16}$ ". The dimension is measured at approximate centerline of body (see Figure 1).

CONDITION	APPARENT CAUSE	CORRECTION
Front and center side roof rails bow upward at hinge joint.	Control link adjusting plate misaligned. Center side roof rail hinge adjusting screw improperly adjusted.	Adjust control link adjusting plate upward (View "C"). Adjust screw clockwise (View "B").
Folding top dust boot is difficult to install.	Improper stack height due to misaligned control link adjusting plate. Misaligned folding top dust boot female fastener.  Rear seat back assembly is too far forward.  Excessive build-up of padding in side roof rail stay pads.	Adjust control link plate rearward or forward as required (View "C"). Align boot female fastener by trimming edge of fastener mounting plate. To remove plate for rework, slit inner layer of boot rubber reinforcement along side edge of plate. Relocate seat back panel rearward until distance between upper rear edge of seat to forward edge of pinchweld molding is $19\frac{1}{2} \pm \frac{1}{16}$ " (see Fig.1). Repair side stay pads as required.

Top material is too low over windows or side roof rails.	Front roof bow improperly shimmed.  Excessive width in top material.	Install one or two $\frac{1}{8}$ " shims between front roof bow and slat iron (View "B"). W/shims use 4824257 screw ( $\frac{1}{8}$ ") If top is too large, trim off excessive material along side bindings as required; then hand sew binding to top material.
Top material is too high over windows or side roof rails.	Front roof bow improperly shimmed.  Front roof bow felt silencer too high.	Remove shim from between front roof bow and slat iron (View "B"). Trim silencer to within $\frac{1}{8}$ " of top of front roof bow (View "B").
Top material has wrinkles or draws.	Rear quarter trim stick improperly adjusted. Top material improperly installed to center or rear quarter trim stick.	Adjust rear quarter trim stick on side affected. Retack top material as required.
