CHEVROLET SERVICE NEWS

VOLUME 33 JUNE	E, 1961 NUMBER 6
CON	TENTS
Page	Page
Corvair Crankshaft Pulley Removal Revised 1	Refinishing Corvair "95" Body Joints 2
Oil Filter Hose Damage 1	Damaged Convertible Top Stay Pads 3
Installing Demountable Rims	Corvair Engine Thermostat
on Cast Spoke Dual Wheels 2	Body Water Leak Detector
Truck Steering Coupling	Truck Floor Board Replacement

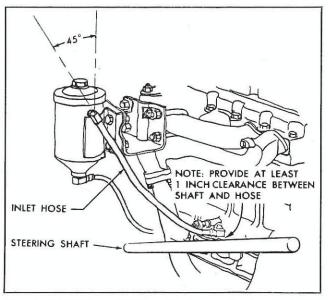
An interference coudition may exist between the oil filter inlet hose and the intermediate steering shaft, on six cylinder engine Passenger Cars equipped with power brakes (Fig. 1). If hose chafing is apparent, replace the inlet hose, and reposition the elbow on the side of the filter so that it points down and inboard at a 45° angle, providing at least 1 inch clearance between the hose and the steering shaft.

Fig. 1-Oil Filter-6 Cyl., with Power Brakes Installed

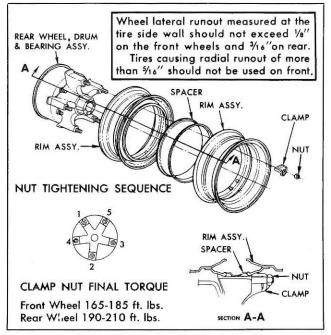
Fig. 2-Truck Cast Spoke Wheels

- 6. Start tightening the clamps uniformly to a low torque (approx. 40-50 ft. lbs.). To insure drawing the rims up evenly, the clamps should be tightened in a cross-diameter sequence as shown in Figure 2.

- 7. At this point the lateral and radial runout should be checked by rotating the assembly against a dial indicator or other base point. Any necessary corrections should be made by backing off on the proper clamps and retightening.
- 8. Complete the assembly by tightening the

clamps to the full recommended torque, again using the cross-diameter sequence method.

NOTE: Do not exceed wheel nut torque specifications for cast rear wheels in attempting to force heel of rim clamp to contact wheel spoke. The late 1959 and 1960-61 clamps do not require heel contact to retain rim-overtorquing could cause parts distortion.

On new assemblies, or after a rim change, parts tend to seat-in and possibly loosen up, therefore, under these circumstances clamp nut torque should be rechecked every day for the first 500 miles. In other than seat-in periods clamp nut torque should be checked approximately every 1,000 miles.

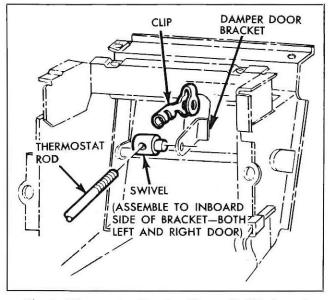
If the swivel is, in error, assembled to the opposite side of the door bracket, thermostat expansion on vehicle operation would cause a bind at the thermostat stem, resulting in leakage and failure of the thermostat.

Fig. 4-Thermostat Damper Door-(L. H. shown)

When adjusting Corvair engine thermostat linkage; the thermostat rod swivel, at both the left and right damper door, must always be assembled to the inboard side of the damper door bracket (Fig. 4). This means that the pin portion of the swivel, that goes through the door bracket, should always be pointed outboard.
