SERVICE NEWS

AUGUST, 1961

CORVAIRE REAR WHEEL BEARING REPLACEMENT

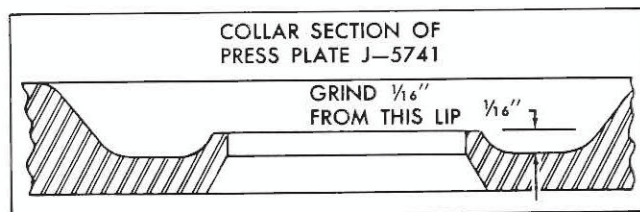
Fig. 1—Rework of Press Plate J-5741

Due to a change in bearing puller ring design, effective in early 1961 Production, it will be necessary to rework press plate J-5741 for use in removal of rear wheel bearings on the later production

Corvaire 500, 700 and 900 Series vehicles. Rework of tool J-5741 will be performed as illustrated in Figure 1. When J-5741 has been reworked, it will then be the same as press plate J-8619-1 which supersedes it in the Kent-Moore tool line.

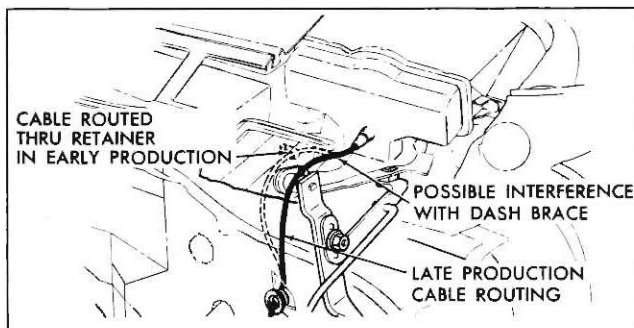
Fig. 5—Passenger Car Speedometer Cable

The speedometer cable routing utilized on early 1961 Passenger Cars can cause cable bind resulting in speedometer drive noise and needle oscillation. This is due to a heavy interference condition that sometimes exists between the speedometer cable and the instrument panel to dash brace. On early production manual transmission equipped vehicles, this condition would be aggravated by the critical bend introduced in the cable as the result of its routing through a plastic retainer on the top of the dash brace. (Fig. 5).

To reduce cable interference at the dash brace and minimize drive shaft bind, a revised speedometer cable routing (Fig. 5) is being used in late production vehicles. To insure a free routing of the speedometer cable in early production vehicles, perform the following:

1. On all vehicles, remove plastic retainer securing the speedometer cable to the dash brace.

2. On manual transmission vehicles, route the cable over the top of the clutch pedal shaft housing (located between the pedal arm and dash brace). See Figure 5.
3. If heavy interference exists between the speedometer cable and dash brace, the brace may be realigned to minimize this interference, as follows:

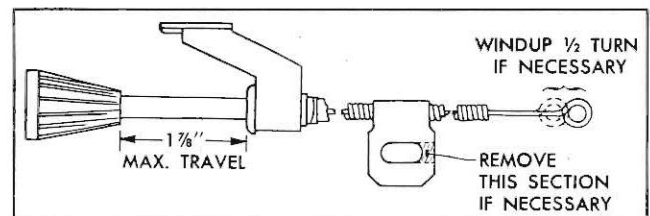
Fig. 7—Air Vent Control Cable

On some early 1961 passenger cars, an objectionable rattle may occur when the right air vent control knob is pulled out to its full travel limit. This rattle is due to excessive control wire travel, that allows the knob and shaft assembly to be pulled more than $1\frac{7}{8}$ " out of its instrument panel guide bracket. To reduce knob travel, proceed as follows:

1. Remove the right cowl side kick pad.
2. Reposition the vent cable slotted clip to relocate the conduit relative to its body attaching point. If necessary, the section of the clip mounting tab, shown as a shaded area in

Figure 7, may be removed to provide additional adjustment.

3. If knob travel still exceeds $1\frac{7}{8}$ " after completion of step #2; use a pair of long nose pliers to wind an additional $\frac{1}{2}$ turn of control wire into the end loop.

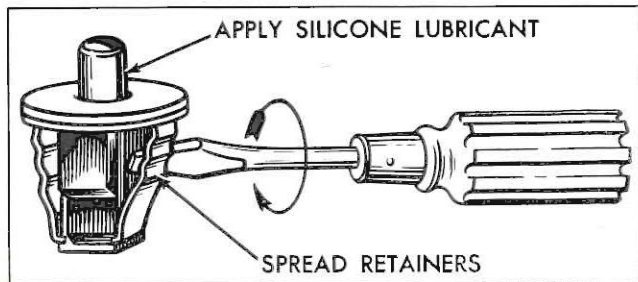
Fig. 8—Door Jamb Light Switch

On 1961 Passenger Cars, front door jamb light switches that are reported as being inoperative or as operating erratically, can in most cases be restored to normal operation in the following manner.

1. Apply a small quantity of silicone lubricant to the side of the switch plunger. Actuate the switch plunger several times to insure distribution of the lubricant.
2. If the switch plunger now operates satisfactorily, but the lamp does not always light when the car door is opened (plunger released), proceed as follows:
 - a. Remove the switch assembly from the hinge pillar.
 - b. Using a screwdriver as shown in Figure 8, spread the switch retainer straps to provide a more positive ground connection for the switch.
 - c. Re-install switch and check operation.

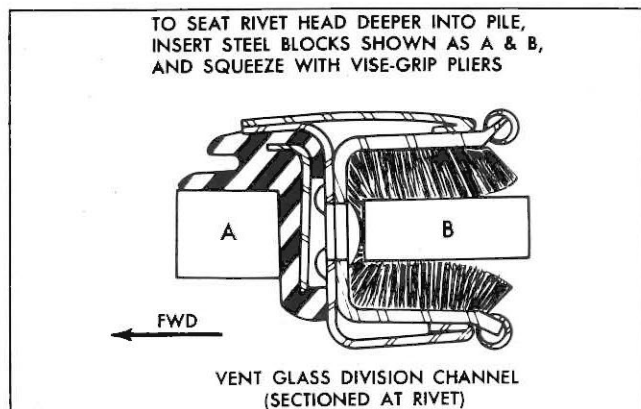
Fig. 9—Compressing Division Channel Rivets

To insure against breakage of front door glass on Corvaire "95" Series vehicles built prior to May 1, 1961, inspect the ventilator glass division channel for presence of rivet heads protruding into the main glass run channel. If rivet heads in the

channel protrude beyond the pile fabric which surrounds them, it could cause the glass to break in the lower front corner of the window.

If this problem is encountered on early production vehicles, the rivet heads in the glass division channel should be recessed below the level of the pile. To compress the rivets, vise-grip pliers can be used to bear upon a pair of steel blocks placed as shown in Figure 9.

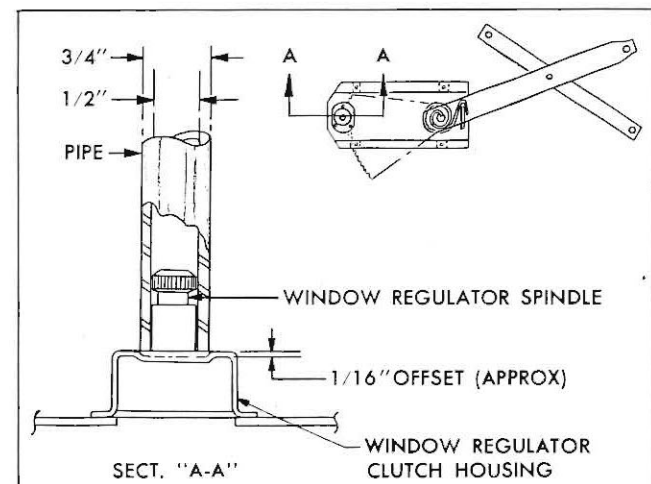
Fig. 10—Window Regulator Clutch Rework

On 1961 Passenger Car and Corvaire vehicles, if a door or quarter window "works down" or drops slightly from the full "up" position, this condition will, in most cases, be caused by slippage within the window regulator clutch assembly. To correct

this problem rework the affected window regulator clutch, as follows:

1. Remove window regulator control handle from spindle.
2. Using a suitable length of $\frac{1}{2}$ " pipe and a hammer, strike the regulator clutch housing to create a $\frac{1}{16}$ " offset in the spindle area of the housing, as shown in Figure 10.
