SERVICE NEWS

VOLUME 35

APRIL, 1963

SERVICING CORVAIR ENGINE VALVES AND VALVE GUIDES

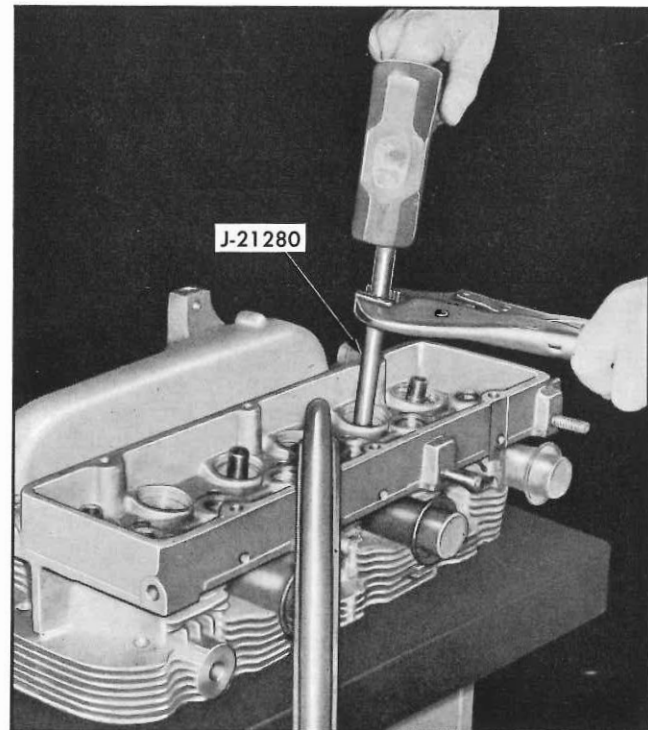
Fig. 1—Removing Corvair Engine Valve Guide

After removing and disassembling the cylinder heads, as described on pages 6A-20 and 6A-33 of the 1961 Corvair Shop Manual, carefully inspect all installed valve guides. Guides showing cracks, or that are otherwise damaged or worn beyond utilization with service oversize valves, should be replaced as follows:

Remove worn guides using the J-21280 Remover and a hammer (2 lb. minimum). Drive valve guide from the spring seat side (Fig. 1) so that the guide will exit on the combustion chamber side of the cylinder head.

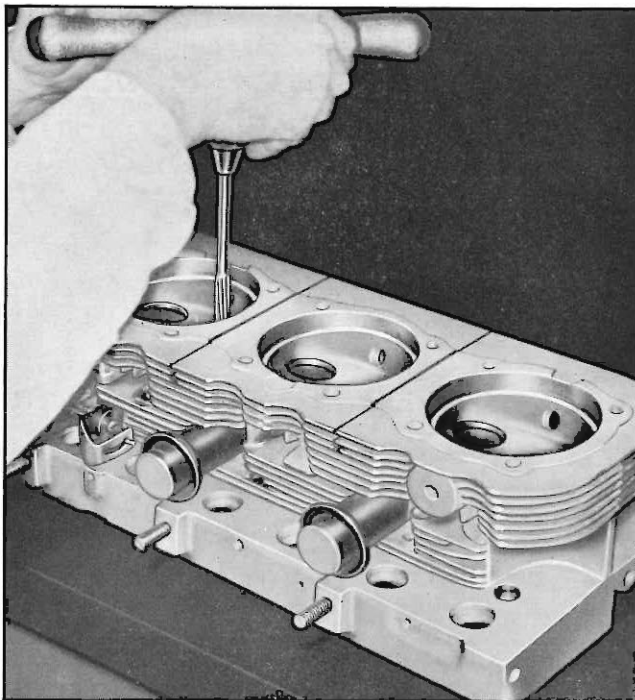
Fig. 2—Reaming Cylinder Head Valve Guide Bore

Wipe out valve guide bore in cylinder head and closely inspect for scoring or damage during guide removal. Use the following method to select the replacement valve guide required for each location:

- a. If guide bore in cylinder head appears smooth and free from scoring, select Part No. 3840811 standard size replacement guide.
- b. If some damage in bore is evident, ream bore with .010" oversize J-21282 Hand Reamer starting at the combustion chamber side and flushing with cutting oil to avoid scoring (Fig. 2). Do not force or remove reamer during ream-

ing operation and pass reamer completely through bore and remove from valve spring side. Wipe finished bore to remove cutting oil and chips; inspect bore. Finish bore diameter should now be .524" - .525". If bore is smooth and free of scoring after reaming, select Part No. 3840812 (.010" O.D. oversize) valve guide.

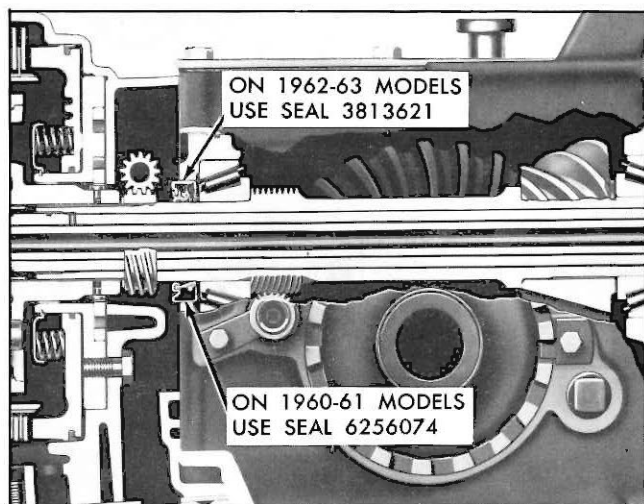
Fig. 5—Pinion Shaft Front Bearing Seal

In cases where low mileage failure of the Powerglide clutch plates has occurred, the drive pinion shaft front bearing seal should always be inspected for leakage of rear axle lubricant into the transmission.

utilize a double lip seal (Part No. 3813621) as the drive pinion shaft front bearing seal (Fig. 5). A single lip seal (Part No. 6256074) was formerly used at this location. The 3813621 double lip seal is now available for service and is recommended for use on 1962-63 models. Replacement usage of the single lip seal, Part No. 6256074, should be restricted to the 1960-61 model vehicles.

To provide improved sealing it is now recommended that pinion front bearing seals, whether of the single or double lip type, be positioned at installation so that the sealing lip having the garter spring will be located adjacent to the bearing. Seal Installer J-8340 will protect the seal from

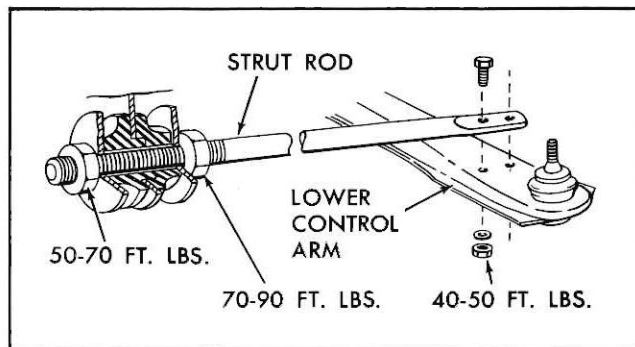
Fig. 6—Chevy II Strut Rod Attachment

The correct installation torque for the front suspension lower control arm pivot bolt nut on 1962-63 Chevy II vehicles is 55-70 ft. lbs. On pages 3-14 of the 1962 Chevy II Shop Manual, step 1 under the heading "Lower Control Arm—Installation" incorrectly states that the pivot bolt nut should be tightened to 90-120 ft. lbs.

Torque specifications for installation of the lower control arm strut rod attaching parts on 1962-63 Chevy II vehicles are shown in Figure 6.

Strut rod attaching parts installation torques shown on pages 3-16 and 14-1 of the 1962 Chevy II Shop Manual and on page 14-1 of the 1963 Chevy II Shop Manual Supplement should be revised to conform with torques specified in Figure 6 of this issue.
