CHEVROLET SERVICE NEWS

VOLUME 36	NOVEME	SER, 1964 NUMBER 1
	CON	ENTS
	Page	Page
Engine Cold Starting	1	Accelerator Pedal Studs 5
Engines Like to Run Warm	3	Corvair Window Glass 5
Radio Receiver and Speaker Removal—Chevrolet	5	Corvair Instrument Cluster Assembly Removal
4-Speed Transmission Shift Lever Reverse Blocker Cable	5	Service Tips 6

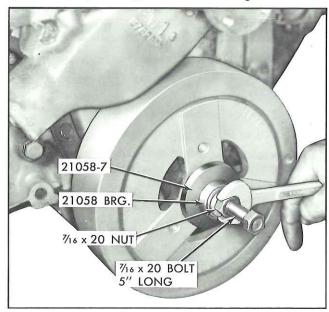
Fig. 6-Balancer installation-V-8.

INSTALLATION OF THE HARMONIC BALANCER ON HIGH PERFORMANCE V-8 AND CORVAIR ENGINES is a pull-on operation using a bolt in the threaded crankshaft. If the existing short bolt is used for this operation it would have to be removed 2 or 3 times to install more spacers and threads may be damaged if the added spacer was too thick. A tool arrangement with a long bolt and nut (assembled as shown in Figs. 6 and 7) eliminates this problem and also provides a method of preventing the crankshaft from turning during the installation procedure.

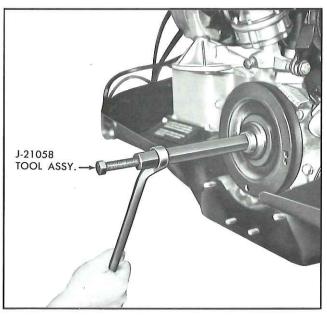
Fig. 7—Balancer installation—Corvair.

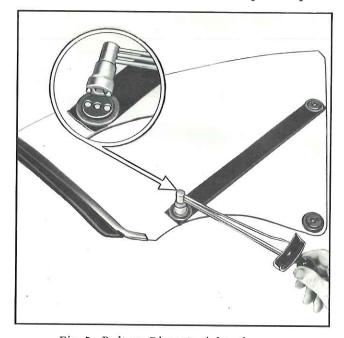
Fig. 5-Bolt-on Glass special tool usage.

windows. The rear door glass retaining nut is hex type, but the quarter panel has a special nut (Fig. 5) that requires a spanner adapter wrench for service. Since the 50 in. lbs. torque is critical, use Kent-Moore tool J-22055 with a 3/8" drive (in. lb.) torque wrench.
