CHEVROLET SERVICE NEWS

VOLUME 36	JUNE-JULY, 196	NUMBER 6
Servicing the 1964 High Performance 409 Engines	1 Thru On. 2 Truck 6 J75) 2 292 Cu ents. 9 Corvai Igate. 9 Chevy 10 Corvai 11 Rear A ting Build	Page d Transmission Countergear and it Washer Usage

Servicing The 1964 High Performance 409 Engines

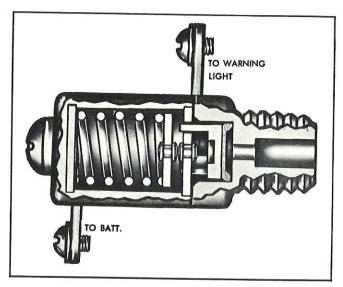
Fig. 2 - Low Pressure Switch-(Cut Away)

Operation of the Low Pressure Indicator may be checked by reducing the reservoir pressure and being sure that the contacts close when the reservoir pressure is between 66 pounds maximum and 54 pounds minimum. The contacts will be closed when the warning light or electrical buzzer operate.

If the low pressure switch is found defective in the operating test, or leakage is evident, repair of the installed switch is not recommended. The switch should be replaced as follows:

- 5. Unscrew the switch from its mounting position.
- 6. Reinstall new switch into the original location and tighten securely.
- 7. Connect air line and electrical connections to the switch.
- 8. Build up the air in the system and check to switch for leaks.
- 9. Check operation of the switch as outlined previously.

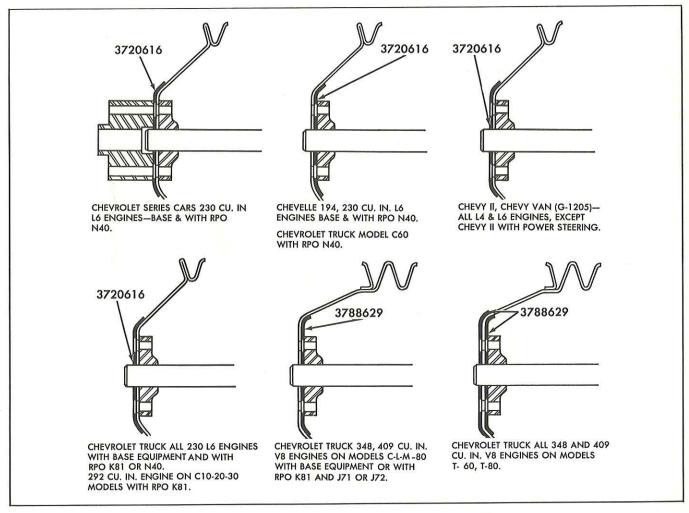
Fig. 6-1964 Engine Water Pump Pulley Reinforcement Usage

Information provided in Figure 6 is presented to clarify proper usage and installation of engine water pump pulley reinforcements. This illustration covers all 1964 engine applications in which the pulley reinforcement is required.

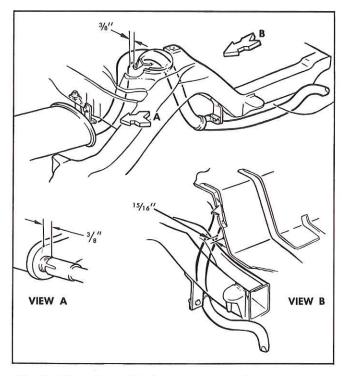
Fig. 8-Chevelle Tail Pipe Clearance with V-8 Engine

On Chevelle vehicles with V-8 engine, the majority of reported axle noise complaints are actually the result of tail pipe interference to the trunk floor compartment and/or the upper spring seat. This condition can exist on either the single or dual exhaust system. Therefore, inspection of the exhaust system should be made before rear axle overhaul is even considered. The change in length of the exhaust system is approximately 7/16 inch when driving at highway speeds above 50 m.p.h. Therefore, the tail pipe clearances shown in Figure 8 must be attained to prevent interference under all operating conditions.

To eliminate an existing interference condition slide the tail pipe further onto the muffler, then if necessary, bend the tail pipe to obtain clearances required.

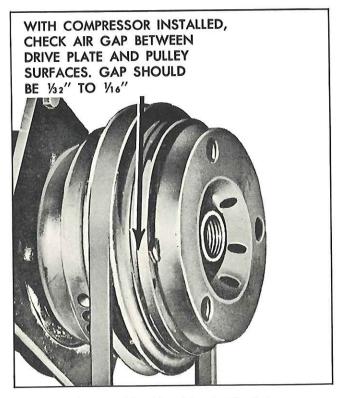
Fig. 9 - Checking Clutch Air Gap

Due to the design of the six cylinder compressor it is possible, either through the use of improper tools or by a blow on the front of the compressor, to move the shaft in the swash plate. If the shaft has been forced back out of its proper position in the swash plate, the carbon face of the shaft seal may not contact the stationary seal seat and a new shaft seal kit will not stop a refrigerant leak. Also, the rear thrust washers and needle bearing most likely were damaged when the shaft was forced rearward in the compressor.

When checking a compressor that has not been disassembled, if the clutch drive plate appears to have an insufficient air gap relative to the pulley face, dislocation of the compressor shaft in the swash plate should be suspected immediately. With the shaft nut installed to proper torque the air gap between the drive plate and pulley should be as indicated in Figure 9.

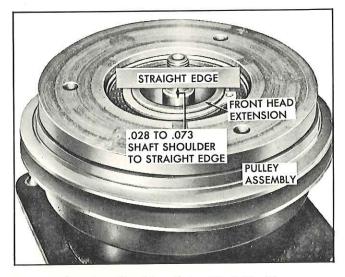
Fig. 10 - Checking Drive Shaft Position

Any dislocation of the shaft in the swash plate can be determined positively by measuring the distance between the end of the front head extension and the flat shoulder on the shaft (shaft

shoulder is the surface which the drive plate hub spacer seats against). See Figure 10. This dimension should be not less than .028" and not more than .073".

To check this dimension, lay a straight edge approximately 21/4 inches long across the end of the front head extension and check gap between straight edge and shaft shoulder. If the shaft has been pushed back in the swash plate (dimension between straight edge and shoulder on shaft more than .073"), disassemble the compressor and replace the shaft and swash plate assembly and the rear thrust washers and needle bearing.

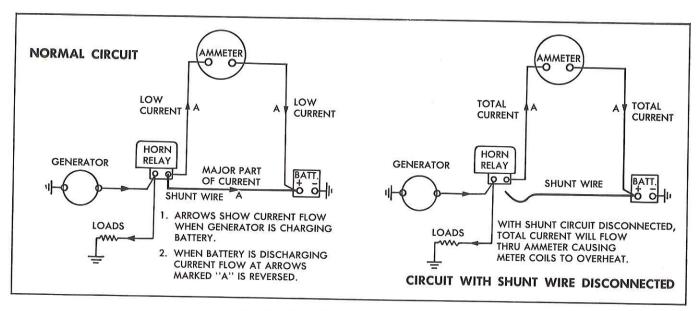
Fig. 11-1964 Truck Ammeter Circuit

For the many years Chevrolet has made a general recommendation that the battery be disconnected before performing service work on electrical equipment. However, it is realized that in certain operational checks of components it is advantageous to perform electrical work with the battery connected. For that reason it is felt necessary to warn service technicians that the ammeter used on trucks can be "burned-out" if the ammeter shunt wire is removed from the horn relay while the battery is connected.

To avoid ammeter damage on trucks, always disconnect the battery before removing the ammeter shunt wire from the horn relay. The shunt wire is red on 6 cylinder engine equipped trucks and black on V-8 engine equipped trucks. It is spliced to the battery positive post connector and routed beneath the radiator upper support, to the horn relay.

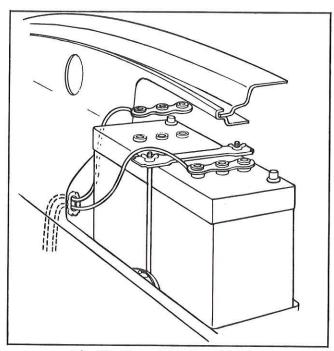
Fig. 13-Corvair Battery Venting

For late production 1964 model Corvairs, venting of the vehicle battery was changed from the familiar six individual vent plugs to two vent plug adaptors and hoses which vent battery gas or vapors to the outside of the engine compartment, as shown in Figure 13. This new method of battery venting was introduced to minimize the corrosive effect of battery gases on the vehicle components.

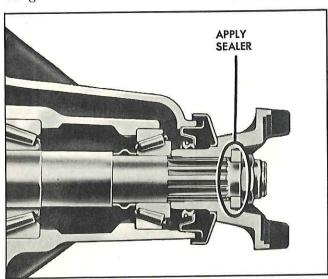
Fig. 15-Sealing Spline Area of Flange

Oil leakage from the rear axle pinion area on some late model passenger cars and light duty trucks can be due to leakage between the pinion shaft and companion flange, rather than past the companion flange seal. If leakage thru the shaft spline is detected, it can be eliminated by removing nut and washer and applying a non-hardening sealer (such as Permatex Type A) to the area shown in Fig. 15. Sealer is applied to this area in production and resealing should be performed if the flange is removed for service work.

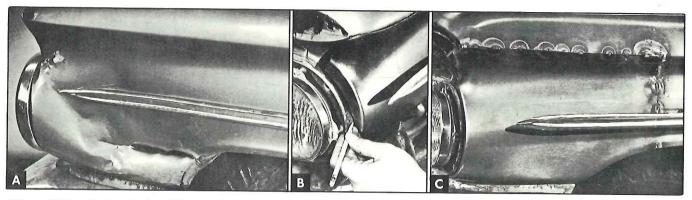
View "A" of the above illustration shows typical damage to the fender lower front section of a 1959 Chevrolet. The localized severe collision damage combined with rust makes it economically advisable to cut out the damaged section and install a Thrift Repair Panel. View "B" shows the repairmen marking the front flange of the replacement panel so that it can be trimmed to fit the headlamp body. The portion of the new panel that extended above the fender crease line has already been cut off to locate the joint along the header. The partial panel was then securely clamped in position and the headlamp body screws were installed before the panels were spot brazed as shown in View "C". After brazing, the seam was filled by paddle soldering; thus making the job complete except for metal finishing and painting. Use of a Thrift Panel to repair the damage described above resulted in a total labor and material cost that was approximately only 20% of that which would have been incurred if the full fender panel had been replaced. This repair is typical of savings that are possible with Chevrolet Thrift Repair Panels.
