CHEVROLET—CENTRAL OFFICE

TECHNICAL SERVICE BULLETIN

1961 CORVAIR "95" RAMPSIDE DOOR SAFETY

CATCH - STRIKER AND ADJUSTMENTS

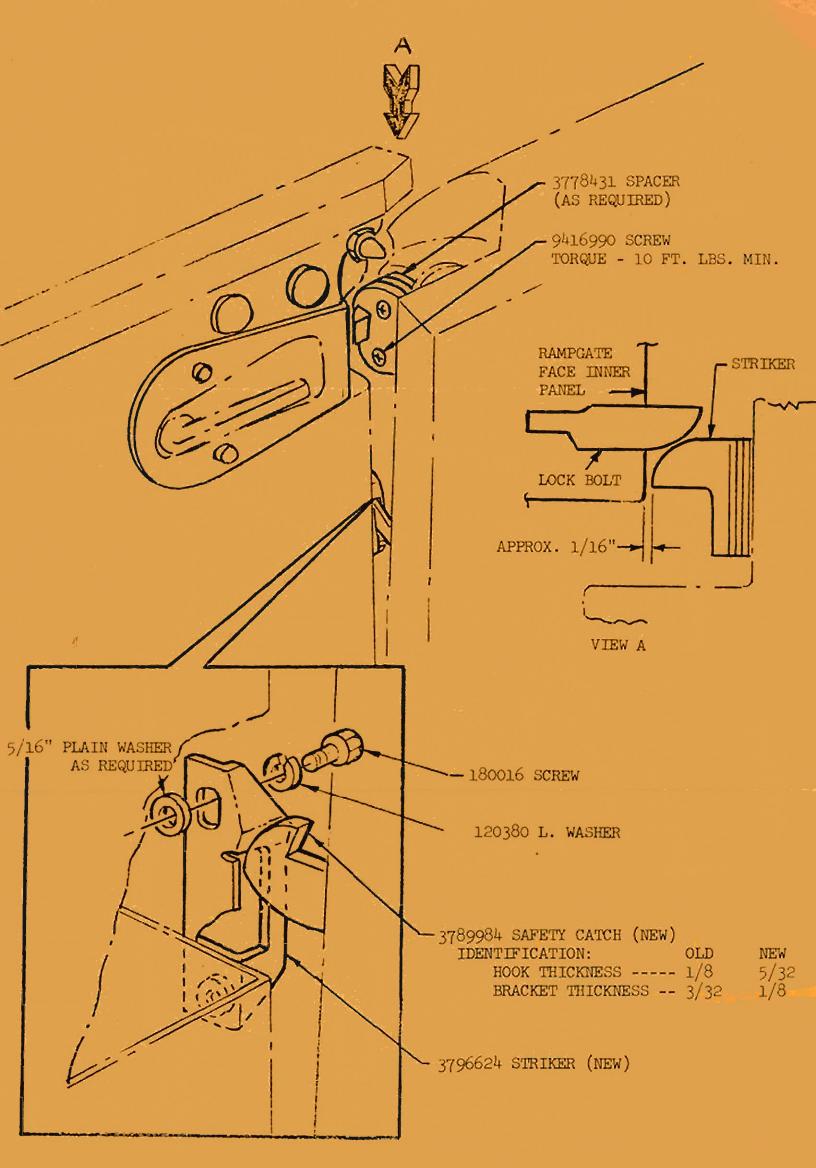
A new ramp door safety catch assembly incorporating increased metal thickness entered production on 11/28/60 effective at Flint with unit Serial #1R124F102775 at St. Louis with #1R124S107214.

Available in service parts is a new safety catch striker. The striker has a window type opening as illustrated in Figure 1 to minimize the possibility of the hook disengaging from the striker.

All units built prior to Serial #1R124F102775 and 1R124S107214 should have the early safety catch and striker replaced with the heavier safety catch and window type striker whenever a Corvair "95" Rampside is available at the dealership.

It is also recommended that both the main lock strikers and safety catch be adjusted, if necessary, to insure that ramp door strikers and the safety catch are positioned to provide adequante main lock and safety catch engagement.

To properly adjust the two main door locks, the strikers should be shimmed with spacers as required to provide 1/16" clearance between the front and rear face of the rampgate inner panel and the end of the strikers as shown in View A on the reverse side. The safety catch can be adjusted by installing 5/16" plain washers between the safety catch striker and rampside door to position the window in the striker in alignment to receive the safety catch as illustrated in Figure 1.
