CHEVROLET—CENTRAL OFFICE

TECHNICAL SERVICE BULLETIN

SUBJECT: ENGINE CUT-OUT RIGHT TURN
1961 CORVAIR AND CORVAIR
"95" MODELS

BULLETIN NO. DR # 493

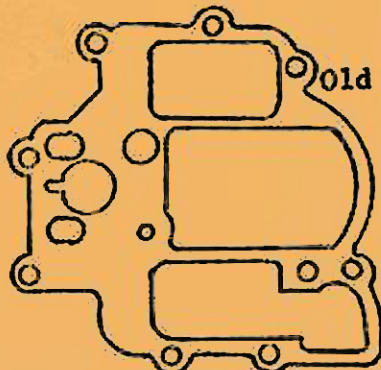
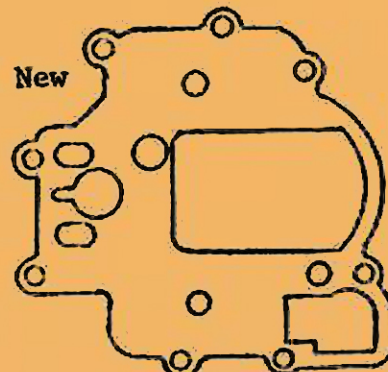
Engine cut-out on 1961 Corvaire and Corvaire "95" models equipped with 3 or 4 speed transmissions may occur on hard right turn due to fuel spilling out of the left carburetor float bowl through the internal vent passage into the carburetor throat.

This condition was corrected approximately 6/27/61 in Production by using carburetors which incorporate a new air horn gasket as shown below. This new gasket has small holes thru to vent each float chamber but is solid below the internal vent passage to the extent necessary to prevent fuel spill-over.

In the event this condition is experienced on earlier units, install in the left hand carburetor only, the new air horn gasket Part No. 7021415. This gasket will also be included in Gasket Kit, Part No. 7016149 and Carburetor Repair Kits, Part Nos. 7016136 and 7017674 when identified with a letter "A" printed after the part number.
