TECHNICAL SERVICE BULLETIN

SUBJECT: ENGINE BLOWER BEARING -
1960-63 CORVAIR AND
CORVAIR "95"

BULLETIN NO. DR #563

DATE November 28, 1962

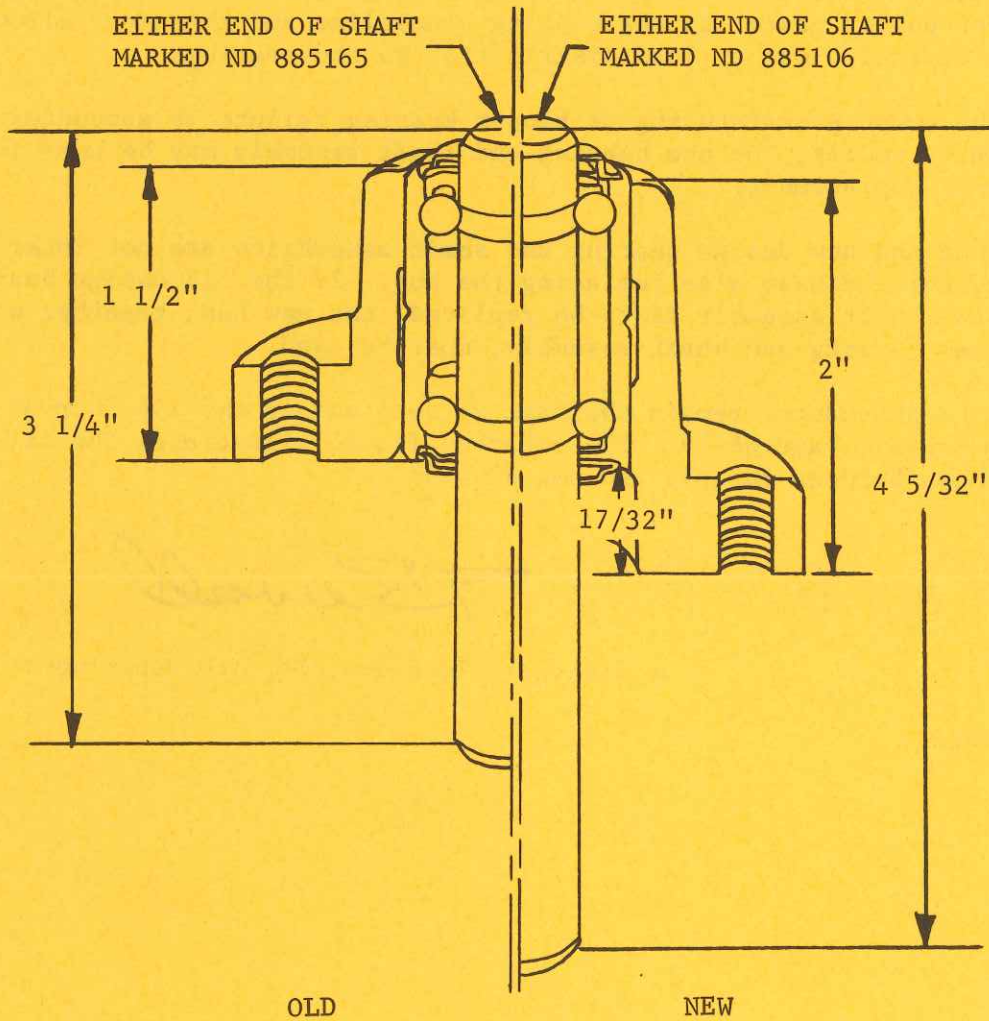
Effective September 13 - Engine date stamp T0913 and later, a new blower bearing assembly entered production on all 1963 Corvair and Corvair "95" models. This new design brings the centerline of the blower pulley nearer to the bearing centerline and therefore allows more effective pulley load distribution on the bearings.

Service procedures remain the same as outlined in the 1961 Corvair Shop Manual, Page 6A-19. The attached figure illustrates the differences between the old and new designs.

In the event premature engine blower bearing failure is encountered on early models, the new bearing and shaft assembly may be used for service replacement.

The old and new design bearing and shaft assemblies are not interchangeable without also replacing the hub. If the old design bearing and shaft assembly is to be replaced, the new hub, together with the new bearing and shaft assembly, must be used.
