CHEVROLET—CENTRAL OFFICE

TECHNICAL SERVICE BULLETIN

SUBJECT: DIFFICULT HOT ENGINE RE-STARTING -
1963 CORVAIR (EXCEPT TURBOCHARGED
MODELS) AND CORVAIR "95"

BULLETIN NO. DR # 589

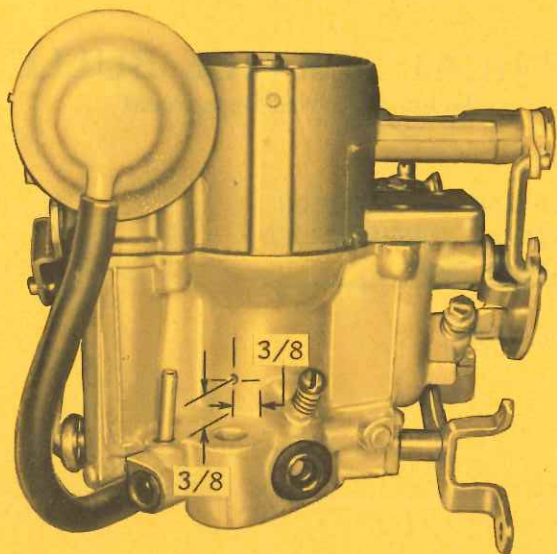
Corvair and Corvair "95" engines may be subject to difficult re-starting after the engine has been shut off when hot, for a short period of time. This condition is the result of fuel vapors accumulating in the induction system of the engine.

Hot starting time may be reduced considerably by drilling a 1/8" diameter hole through the body of each carburetor as illustrated on Page 2, to provide a vent.

CAUTION: This vent hole is not recommended for vehicles operating in extremely dusty areas.

DRILL 1/8" DIA. HOLE
AS SHOWN ABOVE
