HEADLIGHT ADJUSTMENT (OR NOT). Sometimes (O.K. usually) headlight adjusting screws are either frozen or when turned the headlight beam doesn't move. The adjusting screws are held by plastic hardware. The metal screws get corroded and bind. If the screws are forced the plastic breaks. Spraying a lubricant like WD40 the day before (let it soak in) may prevent the breakage of the plastic socket. If the plastic is broken on the later cars (65-69) it can be replaced. Unfortunately, on the early cars (60-64) the plastic hardware is riveted in place and is difficult to replace, but can sometimes be repaired. Our President, **Hector Gonzalez**, supplied both a cracked threaded plastic socket and a unit he repaired with a nylon tie wrap for comparison. See the pictures.

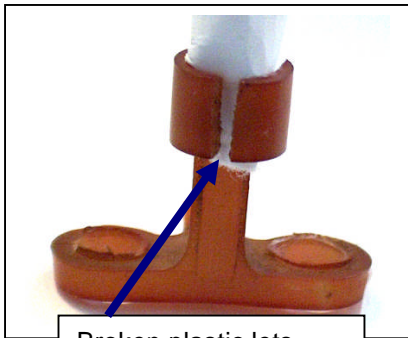
Broken plastic lets adjustment screw slip.

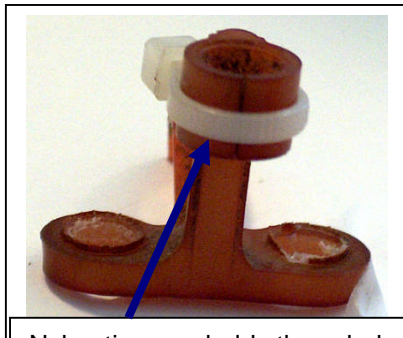
Nylon tie wrap holds threaded plastic collar together.
