## FC Dash Replacement

By Steve Spilatro

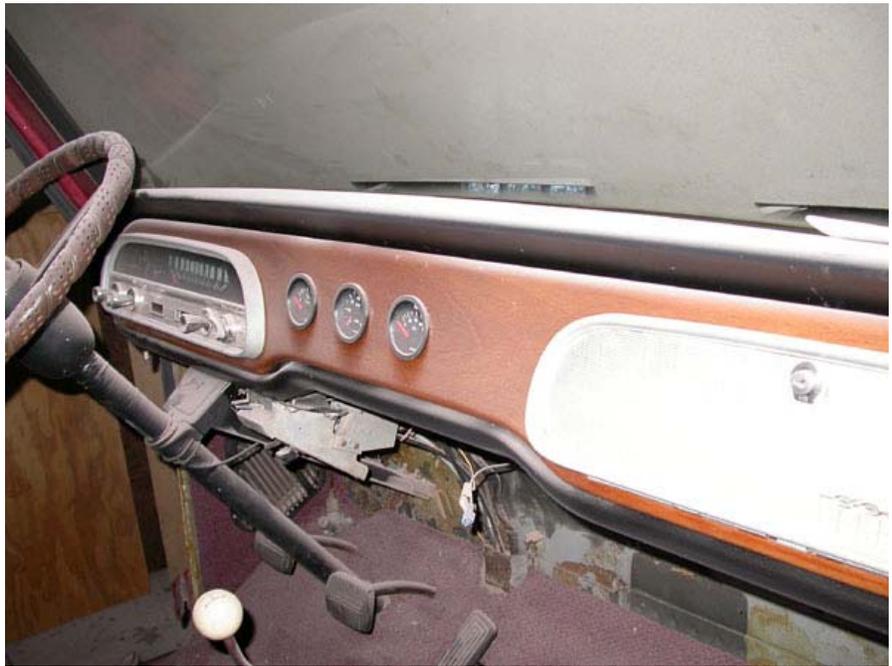
As restoration of my '61 GB progressed, I inevitably had to deal with the dash. When I purchased the van in 1980, the instrument panel had been cut out and replaced with a piece of cheap paneling, which matched the shag rug covering most everything else. Needless to say, grounding of gauges was intermittent at best.

Sometime later I made a mahogany panel which at least was solid and looked decent (at least when not covered with dust as in the [first figure](#)). But the time had come, and not wanting to deal with a complete dash replacement, I opted to replace just the front along with the lower support bracket. While this project may be a rare necessity, possibly some of the techniques might be of use to others.
