This booklet contains a complete review of the discussional slidefilm, Front End Collision Damage Repairs on the 1961 Corvair L.D.F.C. 95 Series. Each man should have one of these booklets for on-the-job reference, and one copy should be retained in the Service Department file of Technical Information.

Minor Front End Damage Repairs

MAJOR FRONT END DAMAGE REPAIRS

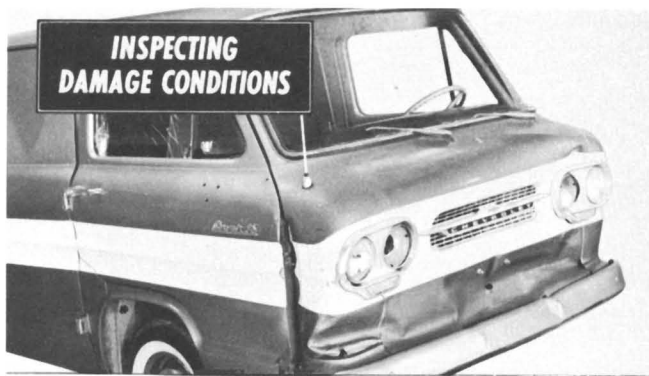
On the exterior, the outer cowl panel above the bumper, the area over the left headlight and the right door are dented.

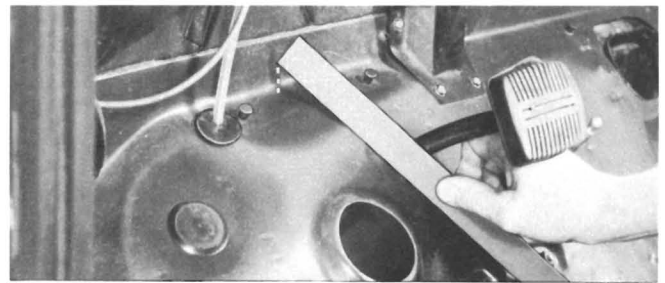
On the interior, the toe panel was forced upward, forming a bulge in the area surrounding the steering gear column opening. Both the steering gear mast jacket and worm shaft were bent. There was no indication of side rail misalignment.

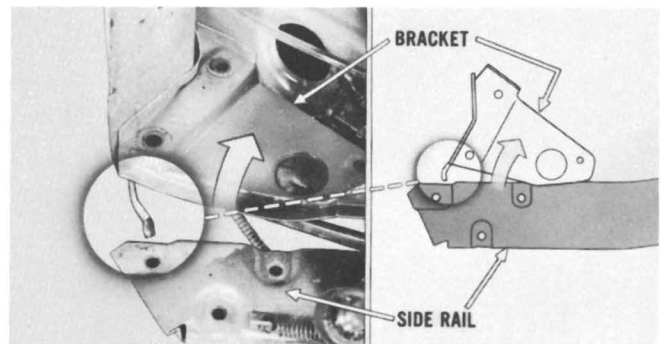
The impact caused the weld to break loose from the mounting bracket extension at the top of the side rail, and forced the bracket upward with the attached steering gear assembly.

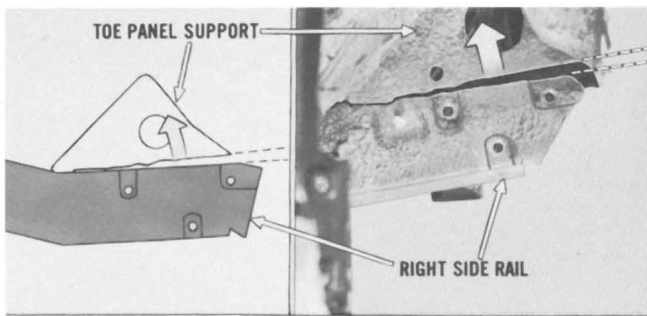
The right toe panel support was also forced upward. However, the front underbody was not misaligned because both toe panel supports broke loose from the side rails and permitted the cowl panel to lift away from the structural members.

Only the lower sections of the outer panels require replacement. Replacement of the complete panels would involve removal, replacement and resealing of the windshield and much more welding. The grille and headlight openings provide surfaces which can be cut and welded easily, leaving the windshield installation and upper panel welds unaffected. The result will be a better and faster job.

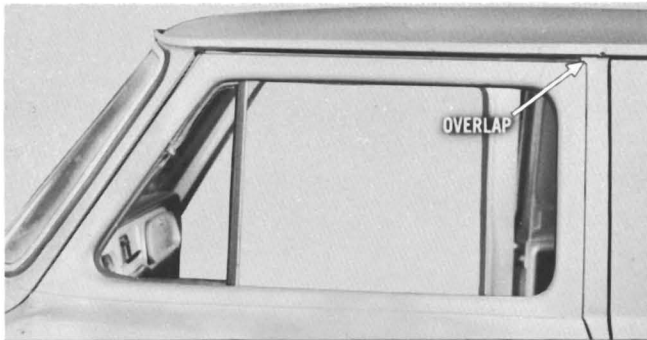
The left front cowl hinge pillar was pushed slightly rearward at the belt line, causing the door to drop and overlap at the lock pillar. This completes the inspection of damage conditions.

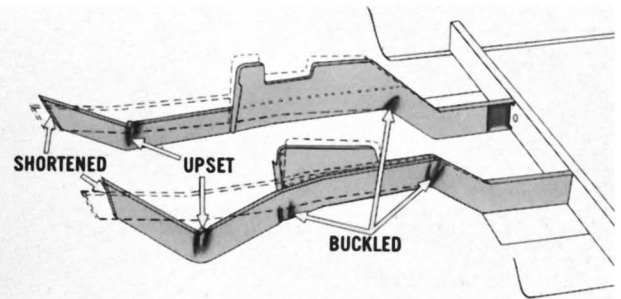
The forward lower underbody structure and front side rails are shortened, upset and buckled severely. The left side rail received most of the impact force and must be replaced. The right side rail can be pulled into shape with the frame machine and the use of heat.

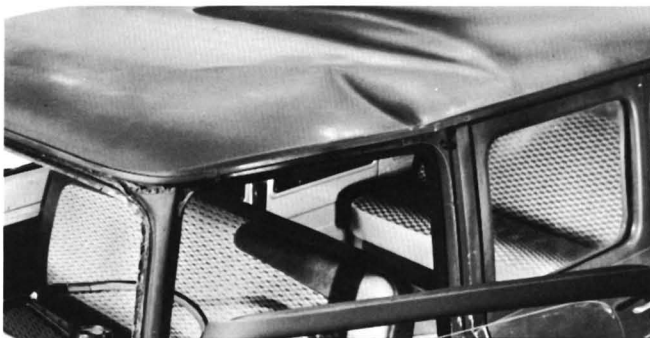
— the roof panel is also damaged. The impact forced the sloping front cowl pillar upward, causing a sharp bend in the roof rail at the lock pillar and buckled the roof panel. On the interior —
