The 140HP Engine - Four Carburetors

By Bob Nichols

Effective February 20, 2024

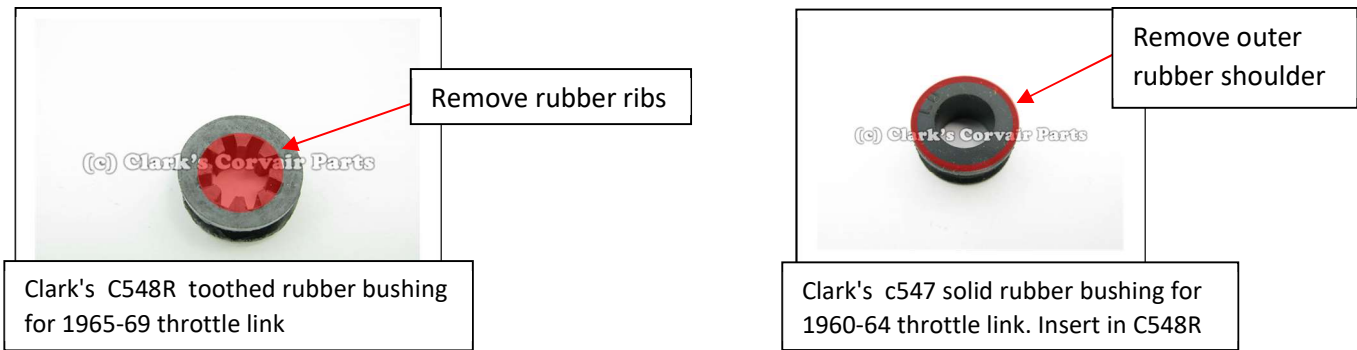
Linkage bushing issue, secondaries will not fully open - A common complaint is all four carburetors will not fully open with the throttle pedal fully depressed. One issue is two ribbed rubber bushing used in the rear throttle linkage under the car. The replacement bushing C548R sold by Clark's Corvair "squishes" causing lost motion in the linkage. The Clark's online site shows where the

bushing is used. One suggested fix is to replace the bushing with a solid flexible piece of hose. Another option is cutting the "ribs" off C548R and cutting down C547 and gluing it (use synthetic rubber adhesive) inside of C548R.
