# FOREWORD

This booklet contains a complete review of the discus-sional slidefilm, **Servicing the Corvair Powerglide Transmission** (Part II, Trouble Shooting and On-the-Car Adjustments). Keep at least one copy of this booklet in the Service Department file of Technical Infor-mation.

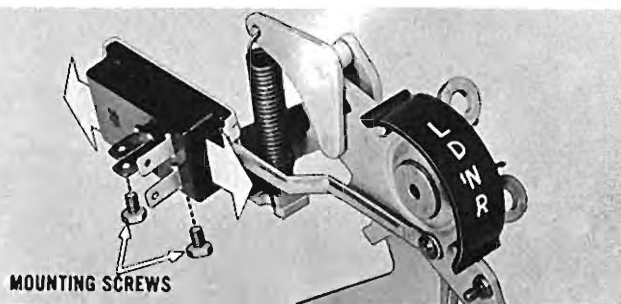
**STEP 1. CHECK NEUTRAL SAFETY SWITCH:** This switch performs two functions. The starter solenoid contacts are wired to prevent the starter from cranking the engine in all ranges except Neutral. The back-up lights (if installed) are wired to a separate set of contacts which close the electrical circuit when in Reverse.

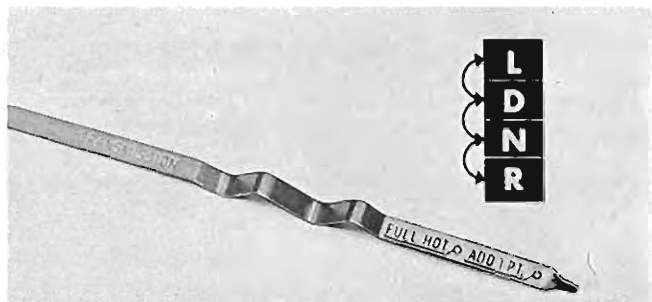
If the starter cranks the engine in "L," "D" or "R" positions, loosen the mounting screws and move the switch housing forward or rearward until the starter operates in "N" position only. Tighten the screws and recheck. Make sure the back-up lights operate (if installed).

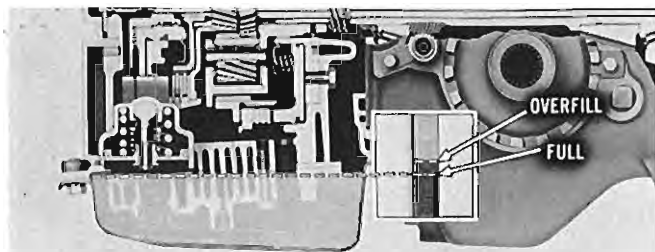
**STEP 2. OIL LEVEL:** With transmission warm and engine at normal idle speed, set hand brake and momentarily place the selector lever in all drive ranges. Return to Neutral. Check oil level on transmission dipstick.  
**NOTE:** LOW to FULL mark requires one pint.

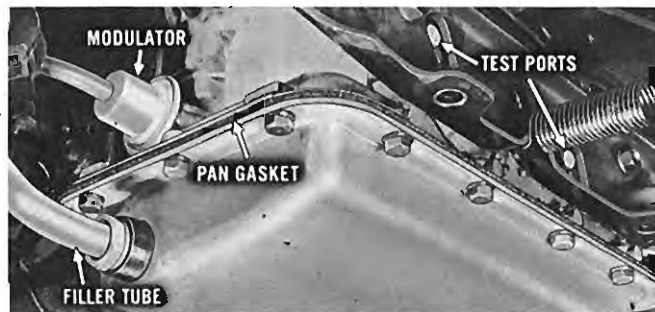
If the oil level is more than  $\frac{1}{8}$ " above the FULL mark, drain the amount required to correct the overfill condition. Too high an oil level can cause serious transmission difficulties, due to oil foaming, particularly during hot weather or when driving steep grades.

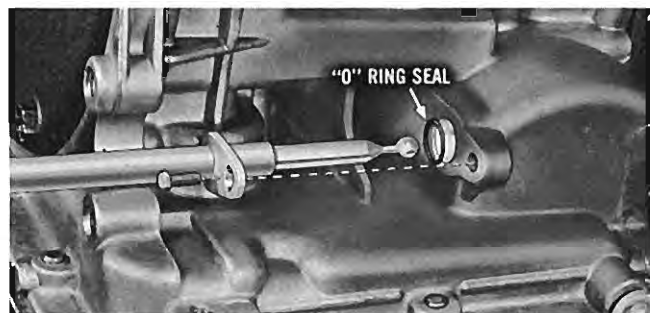
Check for oil leakage at the control cable attachment to the case. Early production models have a threaded nut which tightens and seals the cable sheath to the case. The sheath nut must not be torqued over 10 foot-pounds. Overtightening can crack the case at this point. If the cable nut does not seal at 10 foot-pounds, use a sealer on the threads.

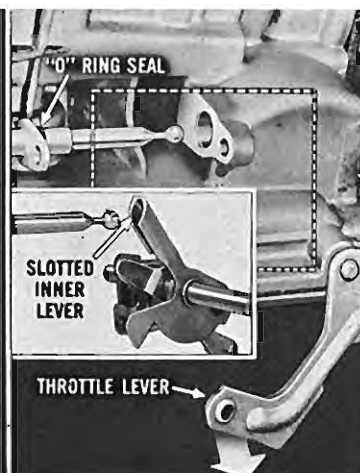
Late production control cables use an "O" ring to provide the seal. If leakage occurs at this point, correction can be made without dropping the oil pan. Place transmission in "D." Remove bracket attaching screw and carefully work cable out of case counterbore. Discard "O" ring.

Install a new "O" ring against the bracket face. Disconnect both rods at throttle lever. Rotate lever fully counterclockwise to place opening in slotted inner lever fully forward. Insert cable into case bore and install bracket attaching screw. Check installation as follows:

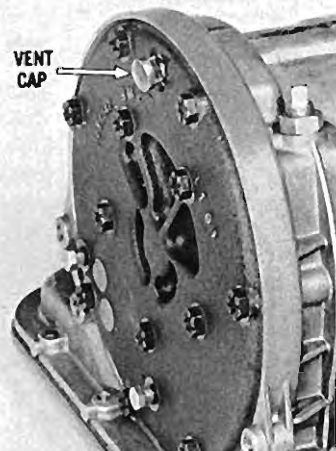
Oil leakage from the front pump body to case seal, the case to rear axle housing gasket, the torque converter housing or the converter hub seal indicates "on-the-bench" service is required. To correct these leakage points, see Part III, OVERHAULING THE CORVAIR POWERGLIDE.

Leakage at gaskets or seals may be caused or "magnified" by a plugged transmission air vent which prevents escape of normal internal air build-up. Rotate the vent cap to dislodge any foreign material which may tend to close the passages.

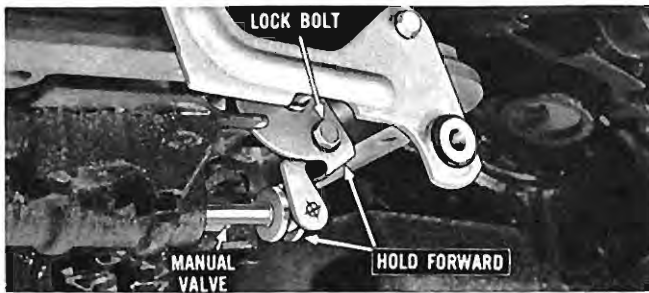
Holding the gauge in position, lightly push both the manual valve and the lower end of the slotted lever toward the front of the transmission. A correctly positioned manual valve should contact the end of the gauge and hold it in place without requiring support.

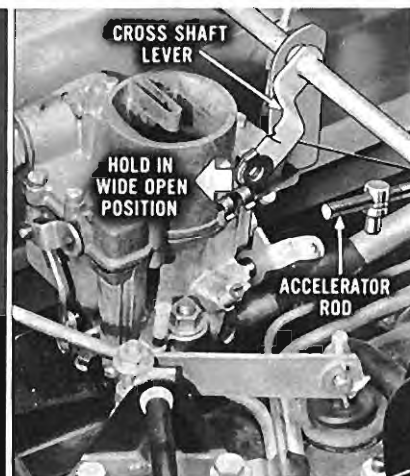
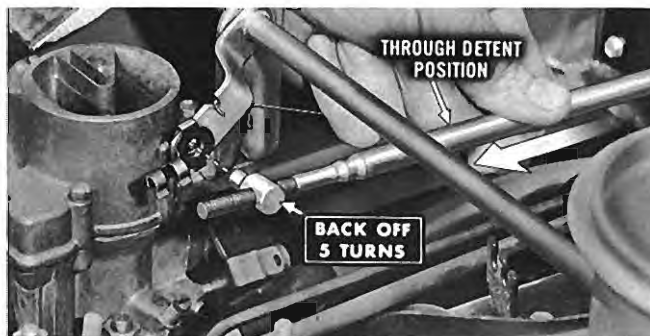
**THROTTLE CONTROL LINKAGE:** Shift points which are not within the normal operating range or no full throttle downshift may be caused by improperly adjusted transmission linkage. To check linkage, remove the mud guard and disconnect the accelerator pedal rod swivel joint.

Disconnect the accelerator rod from the carburetor cross shaft lever. Hold the lever so that the carburetor throttle valves are in the wide open position.

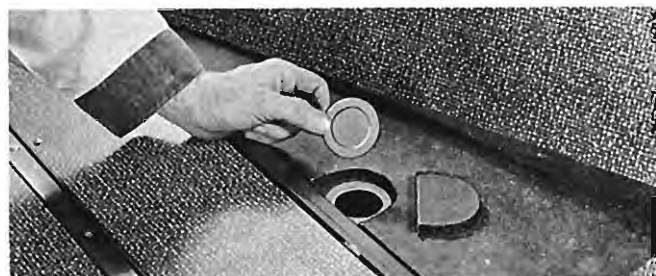
Rotate the throttle lever at the transmission through detent. Firmly hold the lever in this position and check swivel to lever hole alignment. If necessary, turn swivel to align with hole in lever as shown. Attach swivel to lever with clip. Install mud guard and remove wood block.

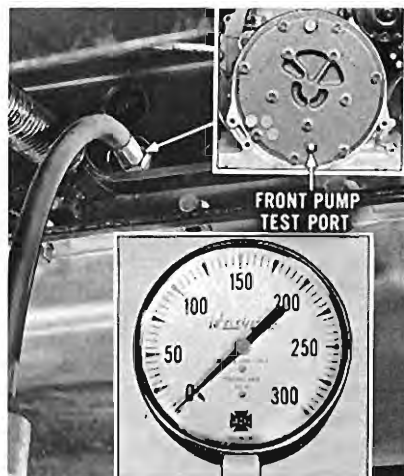
**TEST FRONT PUMP PRESSURES:** If a linkage adjustment does not correct the cause of improper shifting, the difficulty may be incorrect "TV" or governor pressure to the low-drive shift valve. Perform a front and rear pump pressure test before taking a "TV" pressure reading. Proceed as follows:

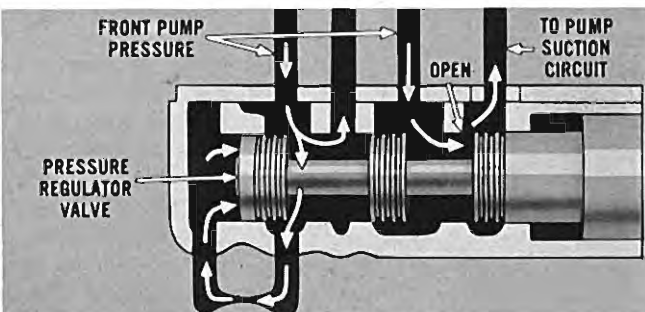
Test front pump oil pressures with the engine at idle speed, the transmission oil level at the FULL mark and at normal operating temperature. Pressures should be checked in all selector ranges, as shown.

RANGE	VACUUM MODULATOR HOSE CONNECTED	VACUUM MODULATOR HOSE DISCONNECTED
REVERSE	81-98 PSI	140-157 PSI
NEUTRAL	47-57 PSI	71-82 PSI
DRIVE	47-57 PSI	71-82 PSI
LOW	71-82 PSI	71-82 PSI

Front pump oil pressures which are above limits with the vacuum modulator hose connected cause:

- HARSH GARAGE SHIFTS and
- SEVERE CLOSED THROTTLE "COAST" DOWNSHIFTS

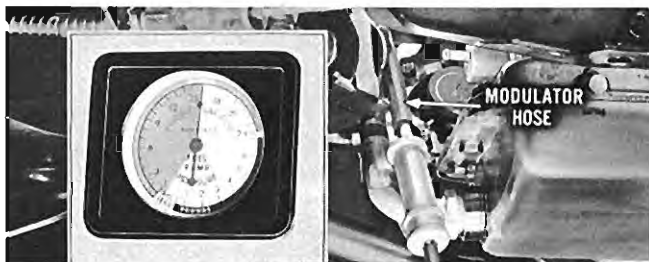
Front pump pressures that are maximum or above limits at all times, and do not change when the vacuum modulator hose is connected, may be due to improper modulator valve action. Test the modulator system for:

- AIR LEAKAGE IN THE MODULATOR VACUUM LINE
- INTERNALLY RESTRICTED OR BLOCKED MODULATOR VACUUM HOSE
- DEFECTIVE VACUUM MODULATOR DIAPHRAGM
- VACUUM MODULATOR VALVE STICKING

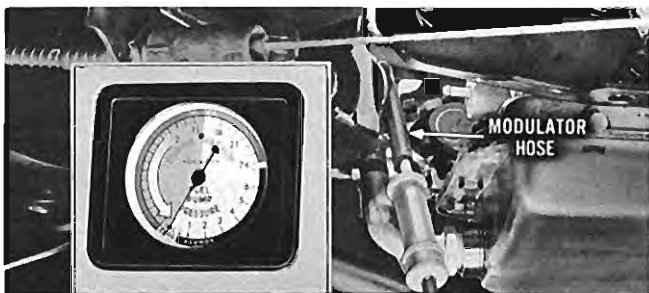
**TEST MODULATOR SYSTEM:** Attach a vacuum gauge to the lower end of the modulator hose and note reading from side of car. At idle speed the gauge should read the same "inches of vacuum" (within 1") as at the upper modulator hose connection. A wide difference in vacuum indicates the hose or tubing is blocked. Correct as necessary.

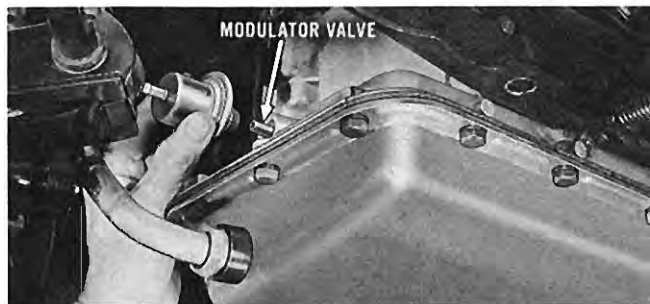
Quickly open the throttle and check for a prompt drop in vacuum. If vacuum does not drop or there is any delay, it indicates an internal restriction in the vacuum line which must be corrected. If both vacuum tests are normal, proceed as follows:

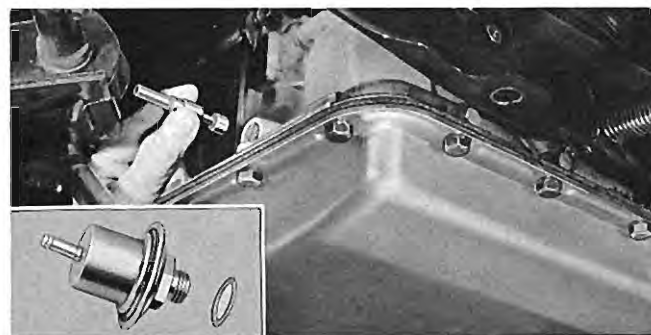
**SPECIAL NOTE:** When it is necessary to remove a small burr or imperfection from the modulator valve (or any valve in the hydraulic circuit), follow these important details:

1. All valve lands must remain sharp and square (never attempt to chamfer).
2. When using a slip-stone, place the stone on the bench and rub the valve on the stone.
3. Rotate the valve as it is moved across the stone surface.

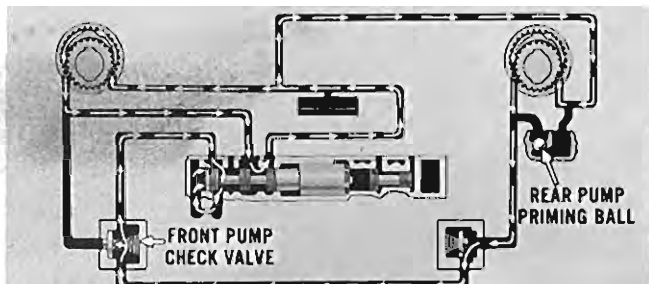
**TEST REAR PUMP OPERATION:** With the rear wheels 3" to 5" off the floor and free to rotate, move the selector lever to "D." Slowly increase engine rpm. Front pump pressure should drop to 0 to 5 psi between 15 to 20 mph. At this speed, the rear pump provides the hydraulic operating pressure and the front pump automatically bypasses to suction.

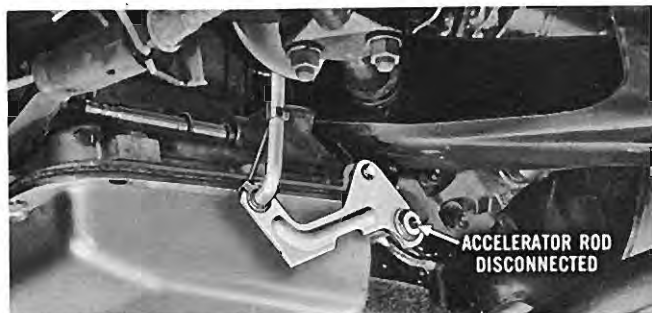
**TEST THROTTLE VALVE (TV) PRESSURES:** Shift points which are rough or not within limits and cannot be corrected with a linkage adjustment may be caused by improper "TV" pressure. Install low reading (0-100 psi) oil pressure gauge in the test port located at the 8 o'clock position on the front pump cover. Take readings from the side of car.

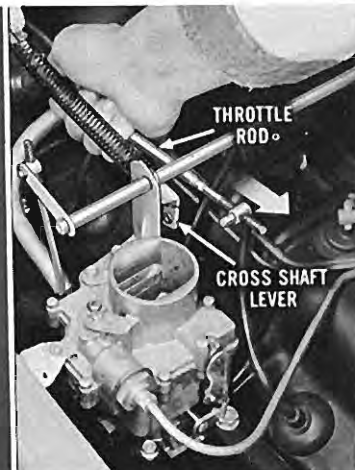
Disconnect the accelerator rod from the transmission throttle lever. This will eliminate the possibility of accelerator pedal interference with throttle lever movement. During the test the rear wheels should be 3" to 5" off the floor.

With engine idling, place transmission in "D" range. Disconnect the throttle rod from the cross shaft lever and the modulator hose from balance tube. Slowly pull rod toward rear of car. Pressure should gradually increase to 40 psi to detent and reach 52 to 54 psi through detent.

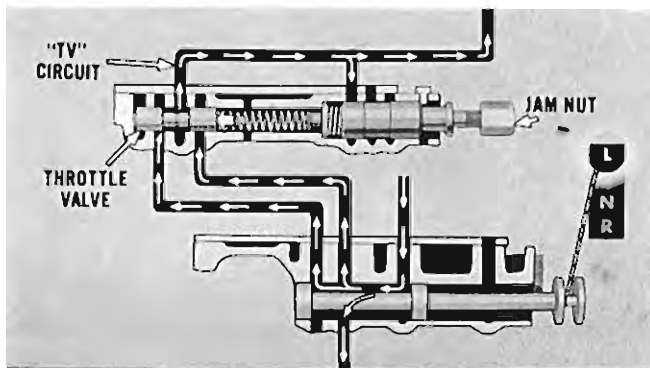
"TV" pressure below 52 psi indicates pressure to the shift valve will be lower at all degrees of throttle lever movement, causing shift points to occur early (low mph).

"TV" pressure above 54 psi indicates pressure to the shift valve will be higher at all degrees of throttle lever movement, causing shift points to occur late (high mph).

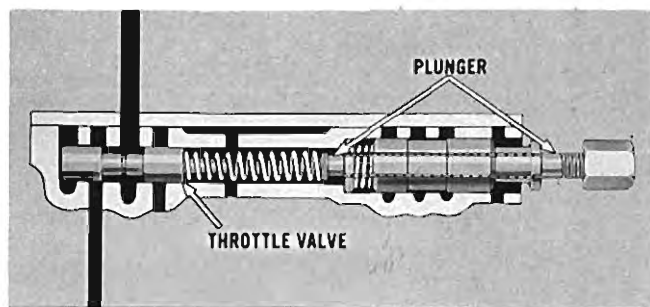
"TV" pressure in manual "L" range should remain constant between 66 to 77 psi, regardless of throttle lever movement.

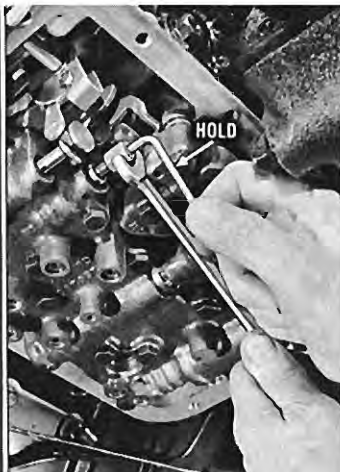
Remove the oil pan following the procedures given earlier. Insert an Allen socket wrench in the end of the throttle valve plunger and hold in a fixed position.

Turn the jam nut counterclockwise 1 full turn to raise "TV" pressure 3 psi. One full turn clockwise lowers "TV" pressure 3 psi. To change pressure 1 psi, turn jam nut 2 "flats" of the hex.

Turning the jam nut in or out varies the length of the throttle valve plunger. This changes the amount of spring force applied to the throttle valve at a given point in throttle plunger movement. Therefore "TV" pressure will change accordingly.

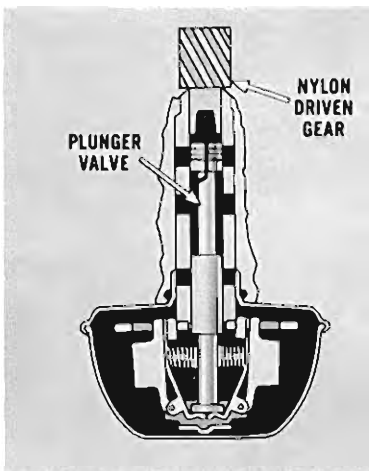
**GOVERNOR:** If there is no upshift or shift points are not correct after checking linkage and oil pressures, the difficulty may be improper, or absence of, governor pressure to the low-drive shift valve. Remove governor and inspect. Check governor seal.

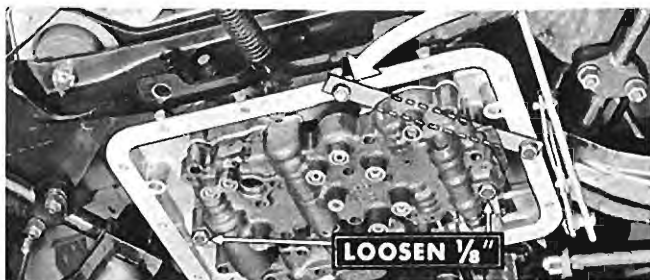
**VALVE BODY REMOVAL:** Drain the oil and remove the pan and screen as described earlier. Remove all but 2 valve body attaching bolts. Before removing these 2 bolts, improvise a sheet metal strap and loosely attach to the case as shown.

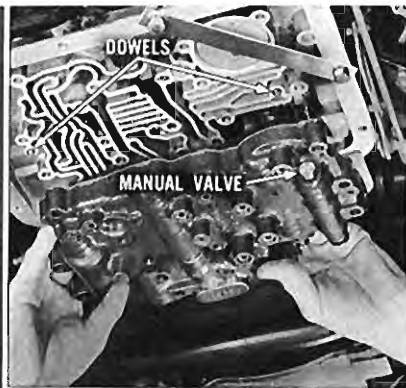
Loosen the 2 valve body bolts about  $\frac{1}{8}$ " so that the strap can be rotated under the stem of the low servo piston. This eliminates the danger of having the low servo piston drop out of its bore and prevents low band internal linkage disengaging when the valve is removed.

With the strap in place, remove remaining bolts. Tap valve body lightly to separate from dowels. Tilt the unit forward during removal to prevent the manual valve from sliding out of its bore.

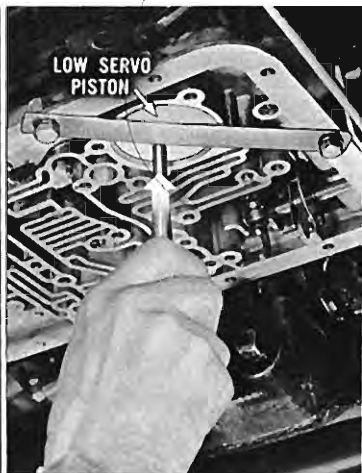
**CHECK LOW SERVO PISTON:** Push upward on the servo piston face as shown. The piston should move about  $\frac{1}{8}$ " to  $\frac{3}{16}$ ". Release pressure. The piston should return to the release position promptly which indicates it is not sticking or binding.

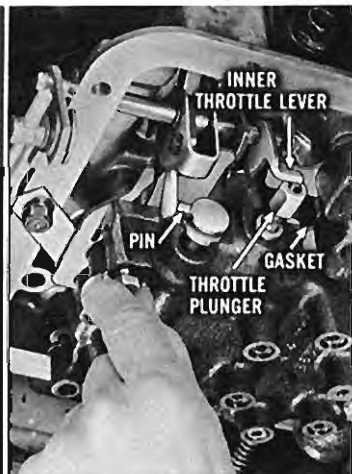
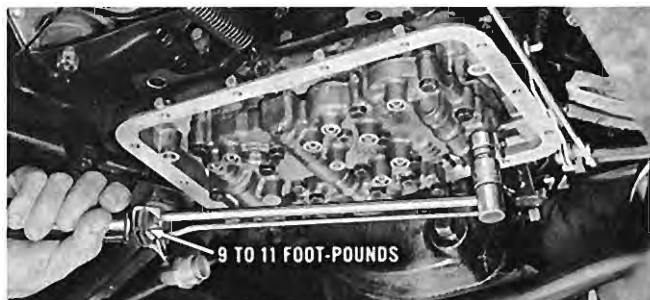
**VALVE BODY INSTALLATION:** Install a new valve body to case gasket on the transfer plate. Use petroleum jelly to hold gasket in position. Loosely install the assembly with 2 attaching bolts. Make sure the manual valve indexes with the pin and the throttle plunger is forward of the inner throttle lever. Finger-tighten bolts and remove strap.

Install and torque valve body attaching bolts 9 to 11 foot-pounds. Stagger the tightening sequence. Over-torquing the bolts can distort the valve body and cause the hydraulic valves to bind. Install "O" ring, oil screen and pan. Refill with oil as described earlier.
