Door/Window handle Spline Repair

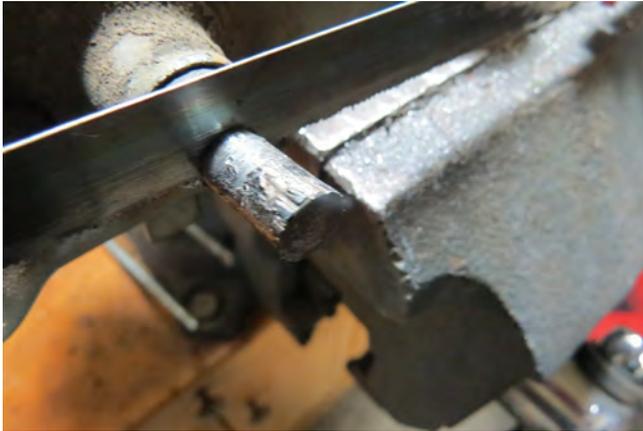
The aft side door on the old Greenbrier had for years been opened from the inside with a pair of Vice-Grips because the splines had been slowly worn away and a regular door handle would no longer do the job. Although the Vise-Grips were completely functional and did the job exceeding well, a vote was taken, and, you guessed it, they had to go.

The Vise-Grips served us well for many years being both stylish and functional, but as you can see, there was no hope for recovery.

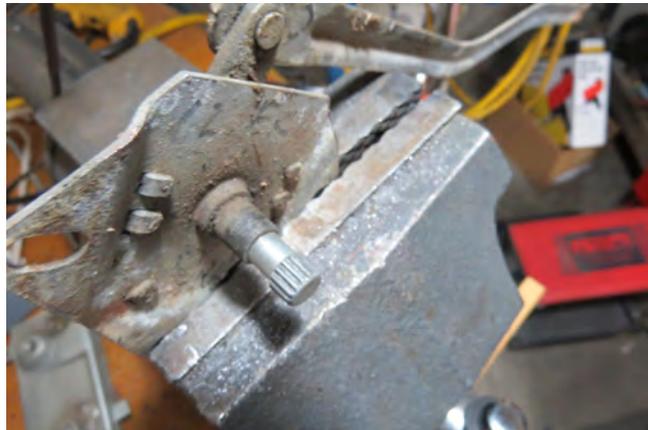
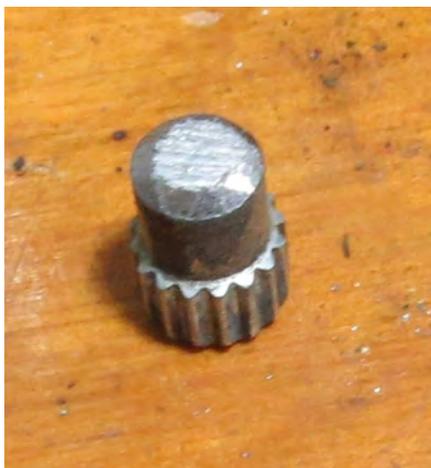
The old spline was removed from the door latch assembly with a hack saw.

The new spline was also removed from the window regulator. The cut was made at the step in the shaft on both splines.

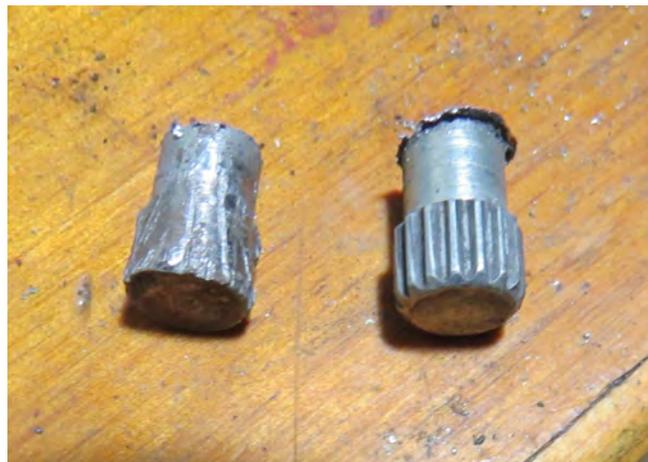
The new spline was beveled in order to allow a little more surface to make the weld a little stronger.

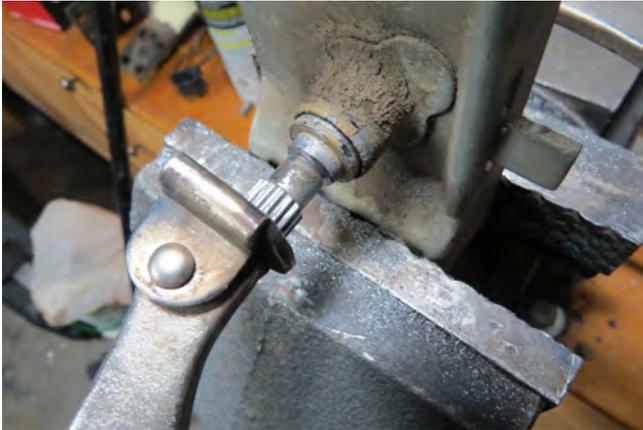
From the step out, the Corvair splines were exactly the same length.

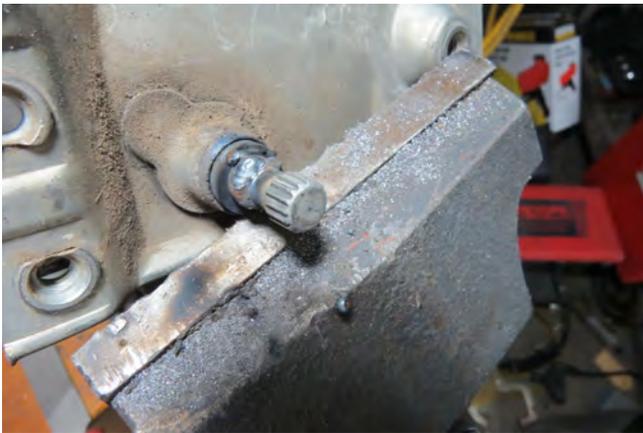
The new spline was clamped in place. Make sure surfaces of the spline and the shaft are nice and flat. It makes clamping much easier.

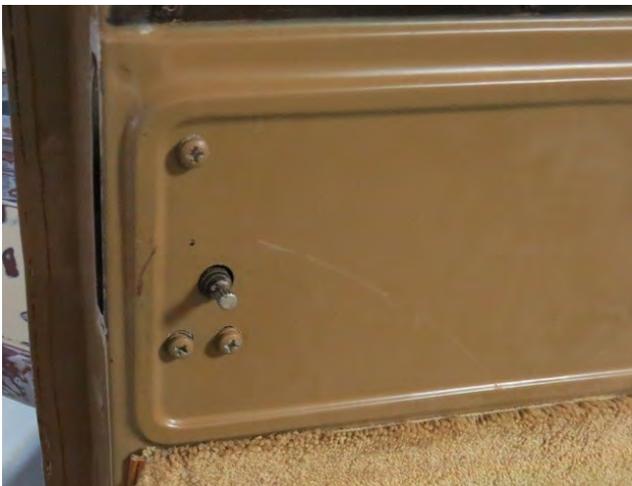
They were then welded together. The weld really didn't need to be cleaned up in this case since the handle slipped on all the way. It's all out of sight when the handle is in place.

The door latch assembly was reinstalled and works like new....or good used!
