This booklet contains a complete review of the discussional slidefilm, Front End Collision Damage Repairs on the 1961 Corvair L.D.F.C. 95 Series. Each man should have one of these booklets for on-the-job reference, and one copy should be retained in the Service Department file of Technical Information.

Minor Front End Damage Repairs

MAJOR FRONT END DAMAGE REPAIRS

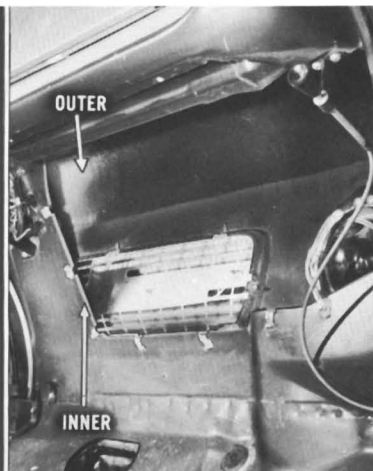
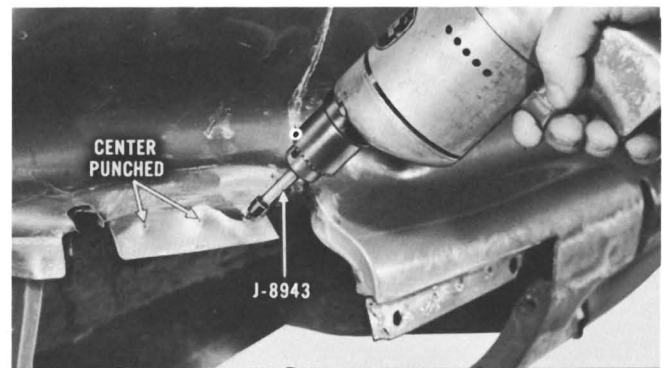
The damage to the outer cowl panel would be easy to straighten if double-wall construction did not block tool access. All the damage is in inaccessible sections of the outer panel, making replacement desirable. This will also simplify inner panel straightening.

All accessible spot welds in the panel sections to be cut out were center-punched to permit cutting with spot-weld cutter J-8943.

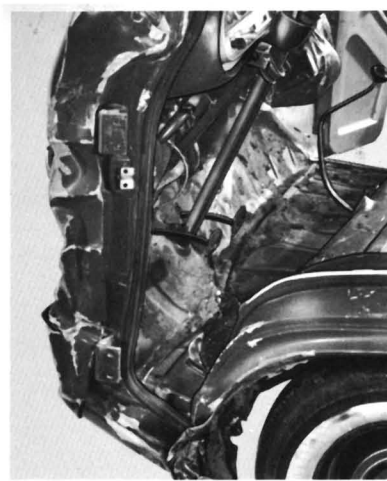
— the toe panel, front floor panel, the left rocker panel assembly, steering column and instrument panel are all damaged extensively. The installation of new parts and assemblies is the only practical and profitable repair procedure.

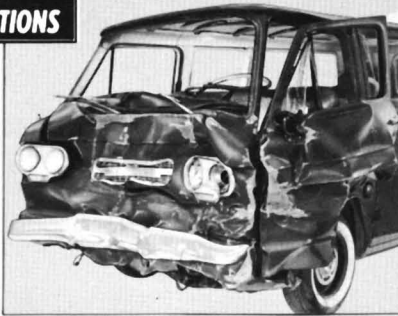
The forward lower underbody structure and front side rails are shortened, upset and buckled severely. The left side rail received most of the impact force and must be replaced. The right side rail can be pulled into shape with the frame machine and the use of heat.

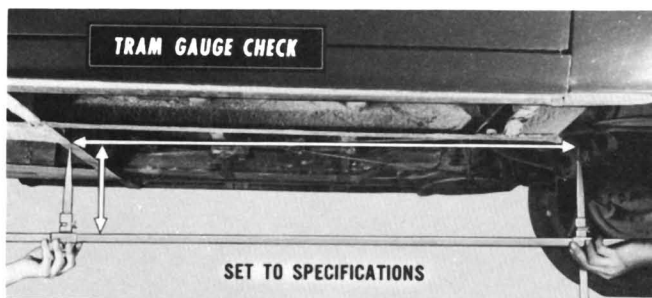
From previous experience with automobiles of conventional construction, it was expected that the rearward shift of the side rails had travelled into the center section. However, checking with a tram gauge, set to 1961 Corvair and Corvan Shop Manual specifications, proved there was no shift.

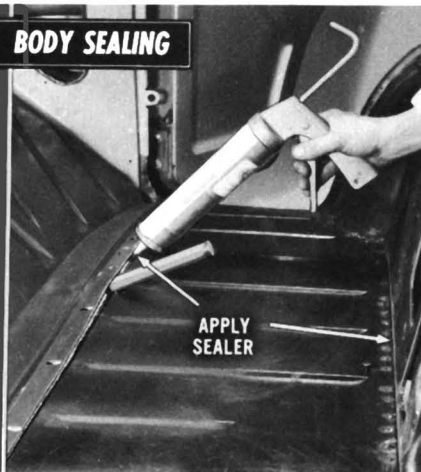
Sealer was applied between the floor panel and toe panel joint before installing the bolts. It was also applied along the welded joint at the rear of the front floor panel, both inside and out.

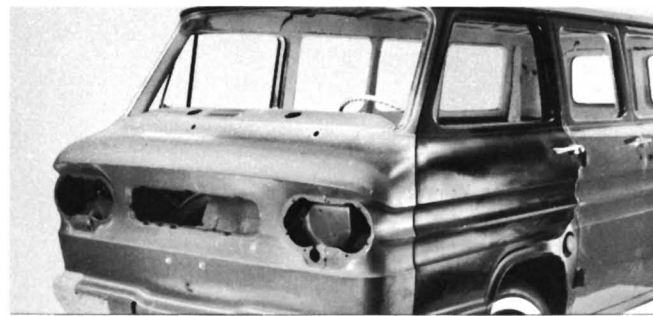
After the brake and clutch pedals were installed, the left outrigger was shifted slightly to permit proper pedal movement in the toe panel openings. The outrigger and door filler reinforcements were then welded in position. All other welding was then completed. Bolts to the header rail and toe panel were installed.

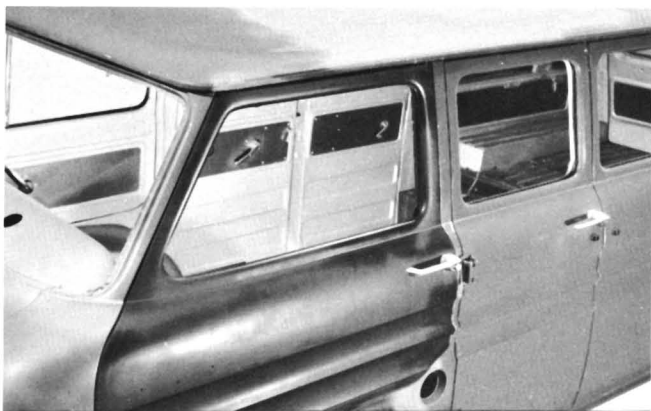
The straightened and rewelded body shell is now ready for painting. The front suspension, gasoline tank and steering gear assembly have been installed. Other parts will be connected and attached after painting. This completes Major Front End Damage Repairs.
