CHEVROLET SERVICE NEWS

VOLUME 33 JUNE	E, 1961 NUMBER 6
CON	TENTS
Page	Page
Corvair Crankshaft Pulley Removal Revised 1	Refinishing Corvair "95" Body Joints 2
Oil Filter Hose Damage 1	Damaged Convertible Top Stay Pads 3
Installing Demountable Rims	Corvair Engine Thermostat
on Cast Spoke Dual Wheels 2	Body Water Leak Detector
Truck Steering Coupling	Truck Floor Board Replacement

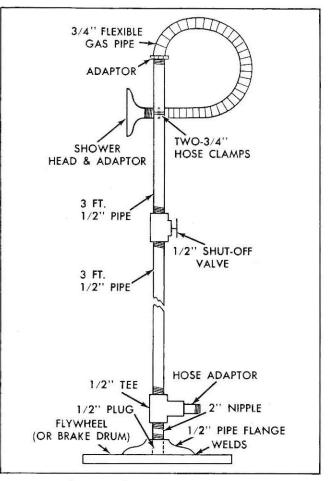
Fig. 5-Body Water Leak Detector

Use of a body water leak detector, similar to that shown in Figure 5, was suggested to a few Chevrolet Dealers by a member of the Field Organization. Dealerships that built and are already using the low-cost spray stand find that correction of body water leaks has become an easy one man operation.

While the spray stand directs water on the suspected leak area, the serviceman can use a flashlight to check the body interior for leaks. In most cases the source of the leak will be detected during the first five minutes of spray operation. However, should one of those rare cases be encountered where the area has to be drenched for a half-hour or more, the serviceman can perform other work while the spray is operating.

After assembling the leak detector, use a pressure gauge to determine the shut-off valve setting that will provide water pressure of approximately 20-25 psi, as desired for leak testing. The amount that the valve was opened to achieve 20-25 psi water pressure should be recorded on the stand as the proper operating setting of the valve.

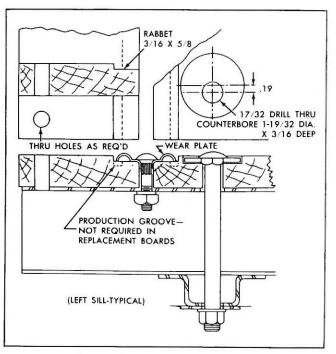
Fig. 6-Pickup Box Floor Boards

When necessary to replace the boards that form the cargo floor on Pickup or Stake trucks, it is recommended that boards of clear yellow pine be used as replacement. At your local lumber yard, select boards from stock widths of either 4", 6", or 8" depending on width of board being replaced. The new boards should be dressed to floor board width, then a simple rabbet and necessary holes added; as shown in Figure 6. Preparation of the boards does not require expensive mill work and can be readily performed at any lumber yard.

Lumber: 1" clear yellow pine-kiln dried. Cut to width and length of board being replaced, then perform mill work illustrated in Figure 6. Coat all surfaces with wood sealer after milling.
