CHEVROLET SERVICE NEWS

VOLUME 36	JUNE-JULY, 196	NUMBER 6
Servicing the 1964 High Performance 409 Engines	1 Thru On. 2 Truck 6 J75) 2 292 Cu ents. 9 Corvai Igate. 9 Chevy 10 Corvai 11 Rear A ting Build	Page d Transmission Countergear and it Washer Usage

Servicing The 1964 High Performance 409 Engines

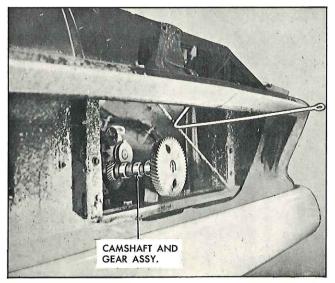
Fig. 12-Removing Camshaft on Light Duty Trucks

It is recommended that the following revised service procedure be followed when necessary to replace the camshaft and/or gear in either a 230 or 292 cu. in. 6 cylinder engine installed in 1964 Chevrolet truck models C, K-10-20 and C30.

- 2. Remove valve rocker cover and gasket
- 3. Loosen rocker arms and remove push rods (Note: on the 292 cu. in. engine the #6 intake and exhaust push rods can not be readily removed because of body interference. Simply lift these two push rods enough for camshaft clearance and then tape or otherwise hold them to prevent the rods slipping down into the engine. If necessary to remove the #6 push rods refer to the article in this issue titled, "292 Cu. In. Engine Push Rod Replacement"

- 19. Remove push rod covers and clean
- 20. Remove hydraulic lifters
- 21. Remove grille assembly. Includes: disconnect headlight wires
- 22. Center punch and drill out rivet in lower right end of radiator tie rod. Bend radiator tie rod as shown in Figure 12

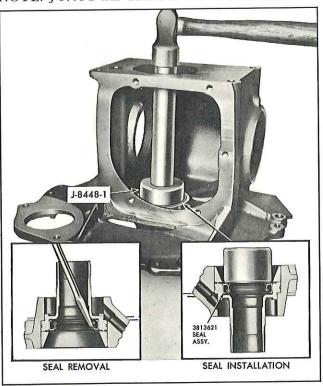
Fig. 16-Pinion Shaft Rear Seal Replacement

Corvair Pinion Shaft Rear Seal

Figure 16 illustrates a time saving method of replacing the Corvair axle pinion shaft rear seal. Using tool J-8448-1 it is not necessary to press out the stator support shaft and pinion rear bearing cup. NOTE: J-8448-1 was added to tool line in 1960.

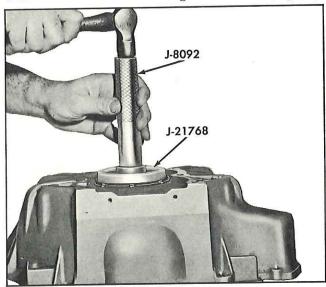
Fig. 17-Installing Clutch Housing Seal

Corvair Clutch Housing Seal

Due to the configuration of the metal case on the improved design Corvair engine Clutch Housing Seal now being serviced, the use of new Installer J-21768 is required in order to prevent distortion of this seal during installation (Fig. 17).
