CORVAN ANTICS

The official Bi-monthly publication of CORVANATICS, a chartered chapter of CORSA. Established Sept. 1972.

ALTERNATE BATTERY BOX by Byron Eaton

IMPROVE FC STOP AND TURN SIGNAL LIGHTS by Dave Palmer

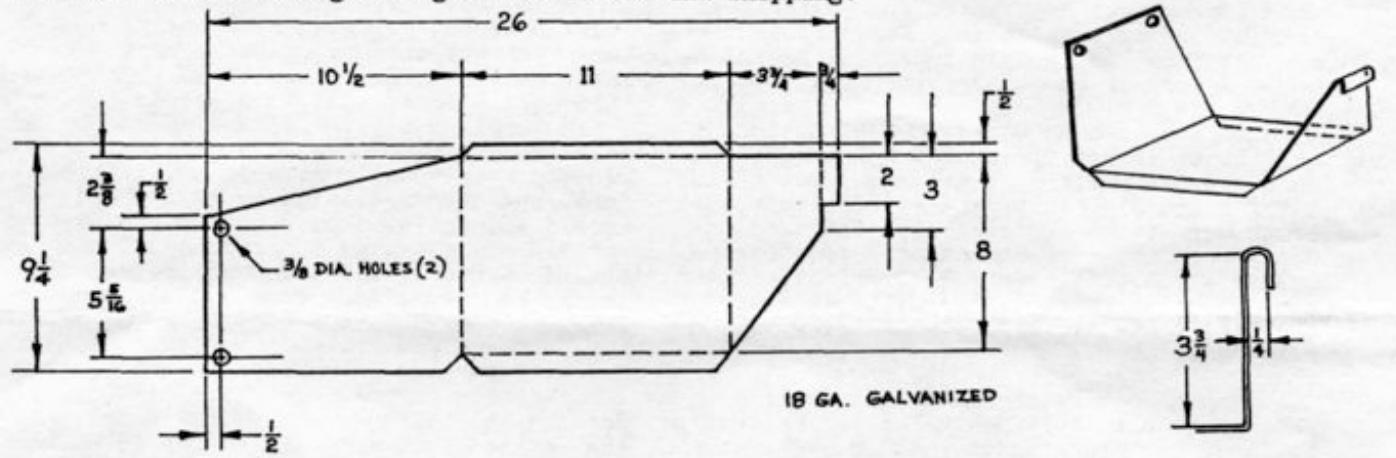
As you can see from the sketch, the adapter is easy to make. If any members lack the material or equipment to make this adapter, I had several made by a sheet metal shop and will sell them for \$20 each including a large HD cable tie and shipping.

Required Parts: New battery mount; positive battery cable, 24 inch; ground battery cable, 36 inch long; group 24F battery (side terminal type recommended but not required; battery holddown.

This alternate battery box attaches with existing fasteners, in front of the left rear wheel. There is <u>no</u> modification required to the vehicle - it can be returned to stock at any time.

INSTALLATION INSTRUCTIONS: 1.Disconnect and remove present battery 2.Raise vehicle and remove left rear tire 3.Clean heads of two hex screws and remove screws 4.Install battery mount into opening ahead of rear wheel. Hook formed lip over frame rail. Align two holes and install screws. Use cable tie provided to secure right side of box to frame. (see sketch) Remove all slack from cable tie. If extremely rough road conditions are expected, substitute long (16") screw type hose clamp for cable tie. 5.Place battery in mount. Install battery holddown. 6.Install positive battery cable to connection on starter. Route cable to battery. 7. Install ground battery cable. Remove bottom starter mounting bolt and install ground cable. Install and tighten bolt. Route cable to battery. 8.Note: Original battery cables are still connected. Positive cable is used to carry power to voltage regulator. Clean positive cable and wrap with electrical tape to avoid shorting to ground. Positive cable may be removed if a suitable wire (10 guage, ed.) is substituted between starter (battery connection) and voltage regulator. Ground cable may be removed, but not required (ed. note: at least a 10 guage wire must be used as a ground between engine and body) 9.Attach cables to battery. Install tire. Lower vehicle.

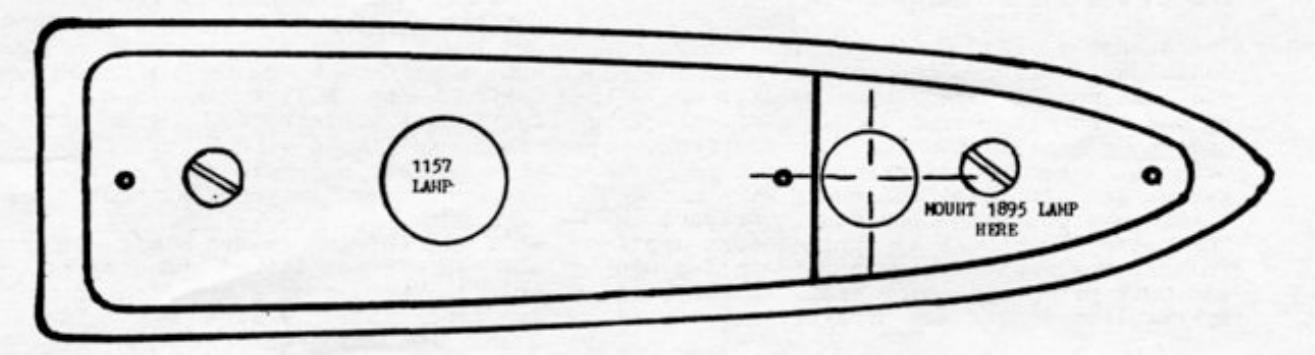
Use the diagram to locate the hole in the tail lamp housing for the 1895 lamp socket. The trick is to locate the lamp in between the housing mounting screw and the lens mounting screw. You may have to bend the tail light mounting bracket inside the fender a little to give clearance for the 1895 lamp socket. I used channel lock pliers to crimp this tab a little. Drill out the housing and snap in the 1895 socket. Seal it in place with RTV silicon. Splice your new lamp into the turn signal wire leading to the light housing. This wire I have seen in several different colors so it would be best to check it with a test light, before cutting away at your wiring.

First go to your parts "junk" collection and locate two dash plate light sockets. These have a metal housing and will carry a #1895 lamp.
