Refurbishing the 1965-69 Manual Transmission Shift Assembly
by Bob Nichols
Last Revision June 19, 2023

The following is about repairing the LM (1965-69) shifter assembly. Comments from Corvair owners suggest the LM floor shifter experiences greater wear vs. the EM floor shifter. The different EM (1960-64) shifter will not be discussed.

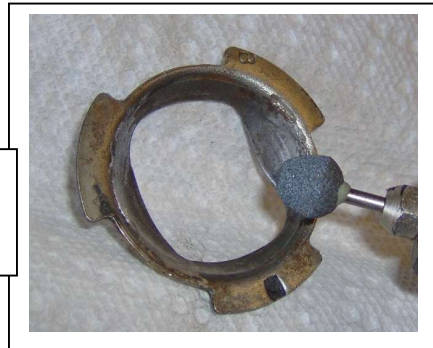
Lower Seat - When the shifter is used for long periods without being lubricated, the lower retaining seat can be worn. Inspect it and remove minor ridges and corrosion so the inner surface is smooth. If badly worn or corroded, then replace lower seat.

Remove corrosion and wear burrs from inside lower seat.

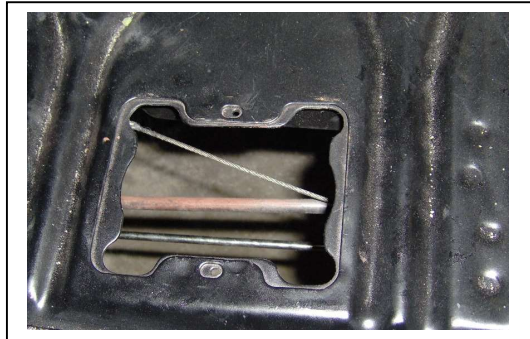
Floor opening.

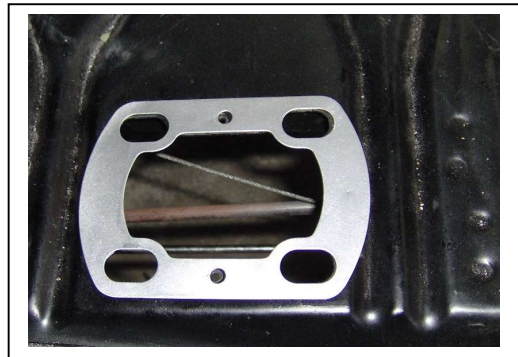
Thin steel shim on top of floor. It is often corroded. Replacement shim from vendors is plastic.

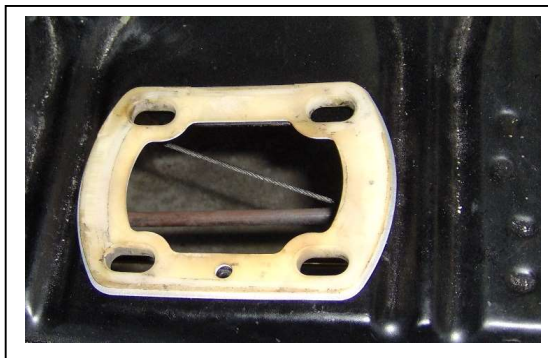
Plastic seal that sits on top of thin steel shim. Shifter lever and base sit on top of seal.

Note the elongated slots the shifter base fits into allow the base to slide fore and aft with the drivetrain movement.

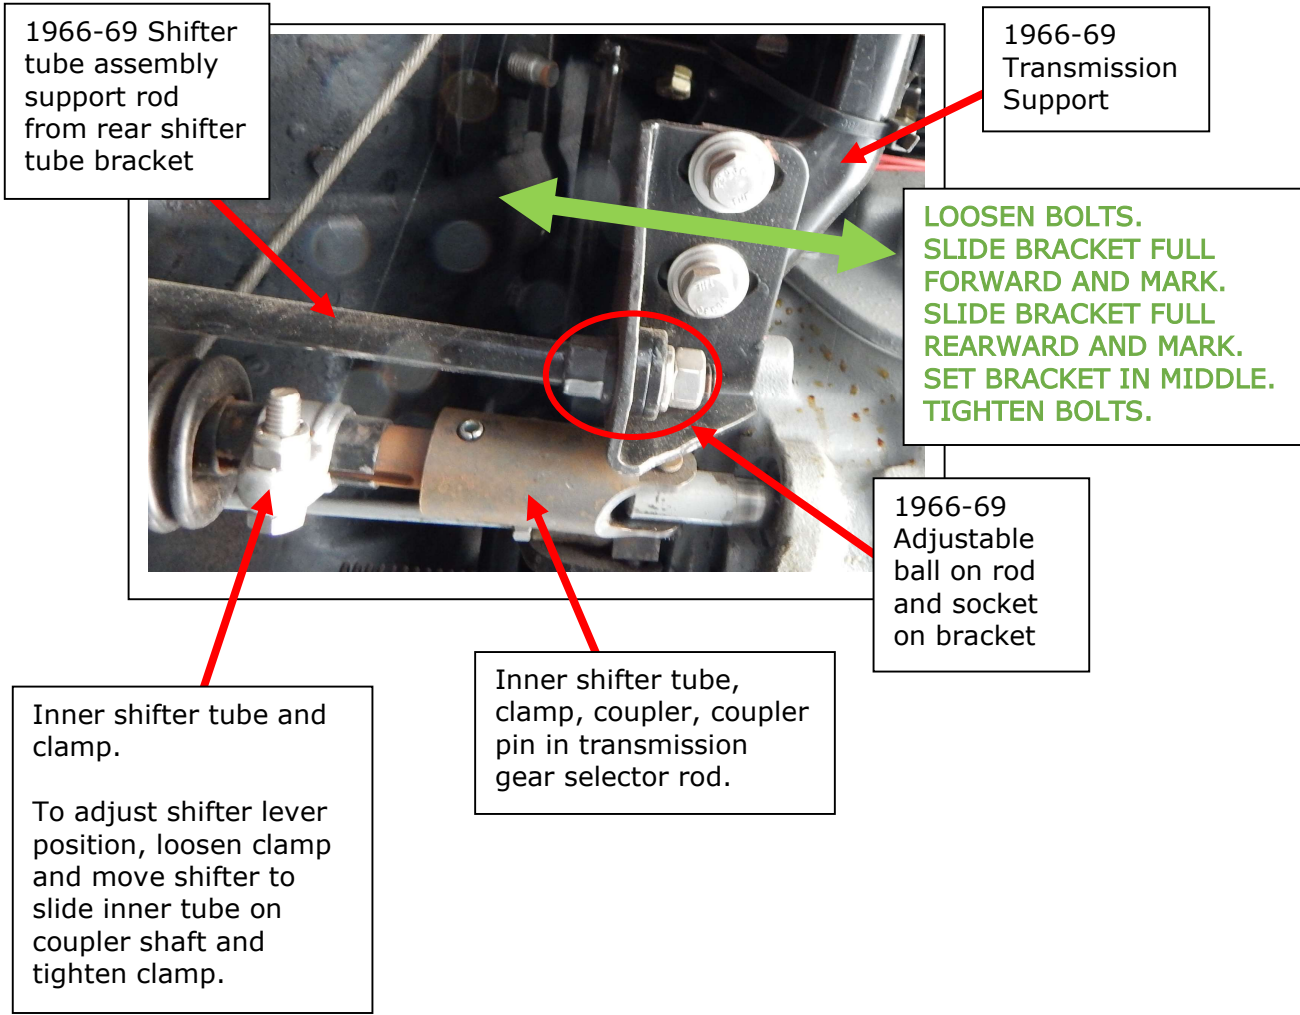
Centering the shifter and shift tube assembly at rear support - The LM floor shifter slides in the floor as it is connected to the transmission support. One issue is making sure the floor shifter is centered in the slots of the shifter plastic seal so the shifter can move fore and aft without hitting the shifter seal slot ends. Once the shifter and tube assembly are installed, loosen the rear shifter tube rod support that bolts to the transmission support.
